**ИНСПЕКЦИЈА ЗА БЕЗБЕДНОСТ НА ПАТ –
Некомпатибилност помеѓу функцијата на патот и
типичниот пресек – белградска северна артериска
тангента**

**ROAD SAFETY INSPECTION – Incompatibility between
the function of the road and the typical cross section –
Belgrade’s Northern Arterian Tangent**

Sanja Fric¹, Filip Trpčevski², Dejan Gavran³, Vladan Ilić⁴, Stefan Vranjevac⁵, Miloš Lukić⁶

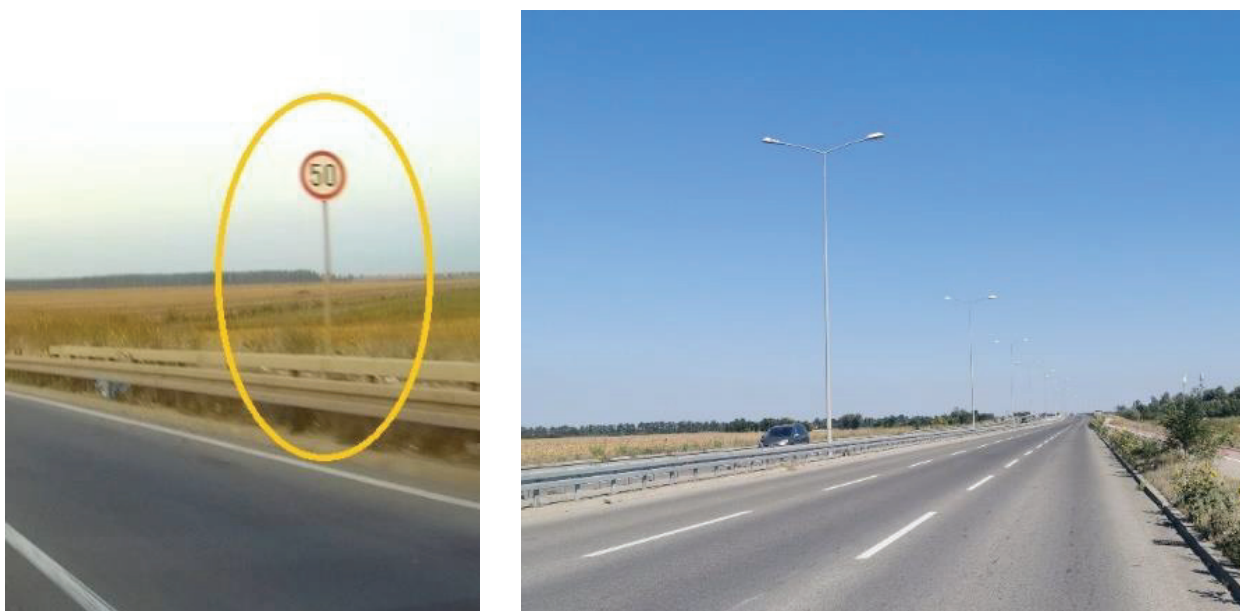
However, the actual speeds on the road are much higher, with the lowest speed starting with 52km/h and reaching 126km/h. The average speed observed is around 90 km/h. Thus, all the vehicles are travelling at speeds exceeding the actual speed limit, around 88% of vehicles exceeding the limit by more than 20km/h.

The speeds registered in the field confirm the incompatibility between the planned function of the road and the parameters of the existing traffic flow.

Figure 2. Speed limit sign and typical cross section

Though there are some preconditions for reaching the speeds of 130km/h, the recommendation is to set the new speed limit of 80km/h which is compatible with the high-speed motorway in an urban environment. Intersection's interval is also compatible with the increased speed limit.

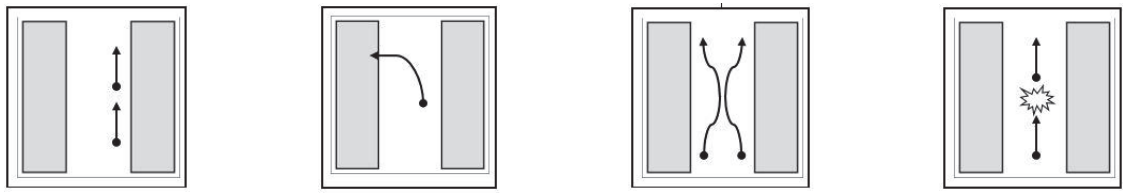
The types of accidents not only expected, but acctually occuring on this section of the road, are illustrated in Figure 3:

Figure 3. Expecting/occurring possible traffic accidents

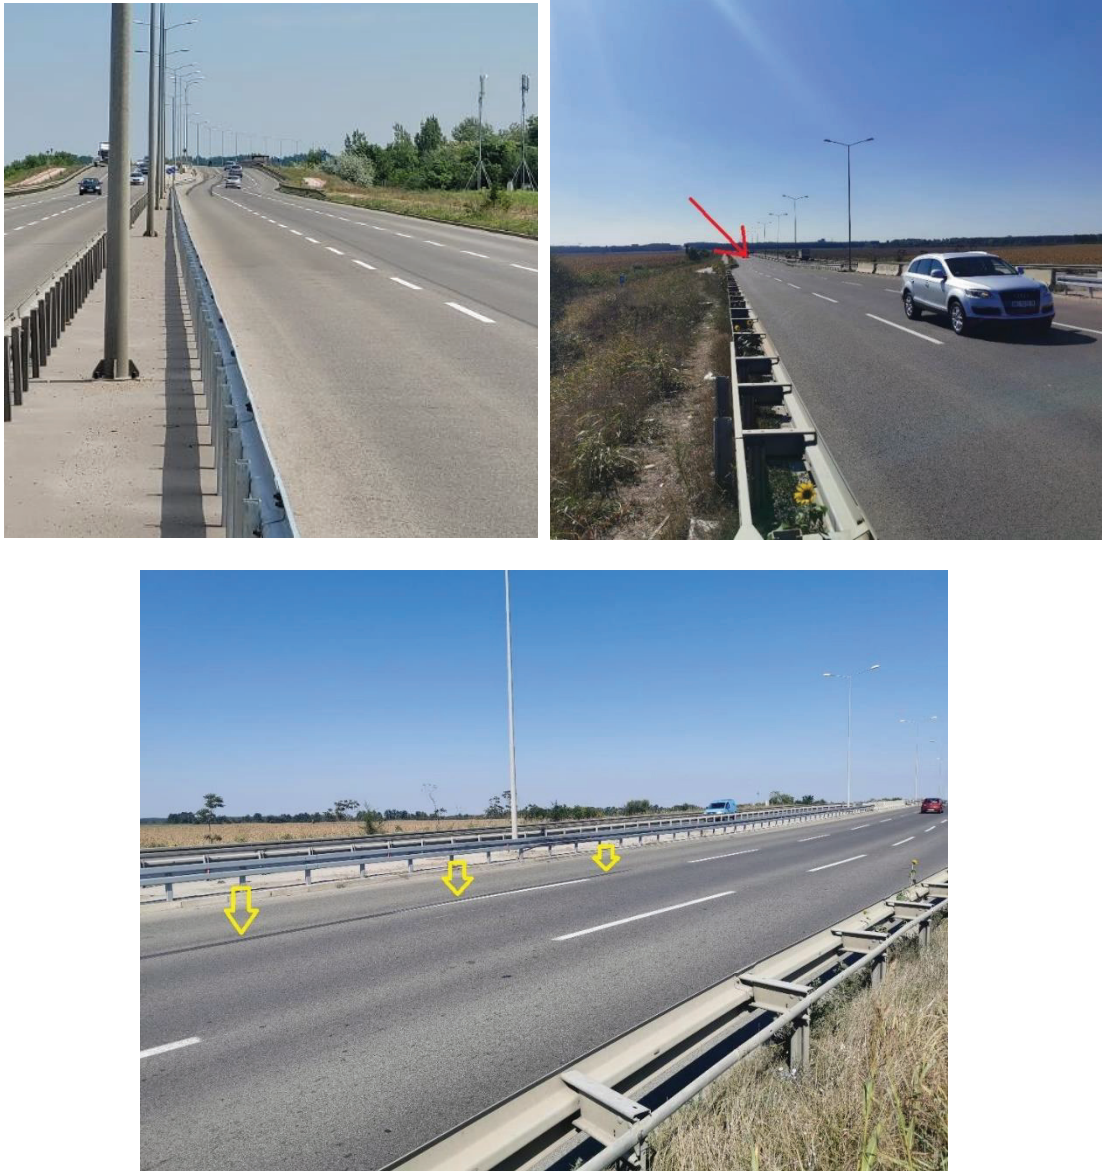
Geometry of the median deviation is constructed with the parameters compatible with the operating speed of 50km/h. Practically, there is a sharp deviation of all traffic lanes within the future intersection's zone. This is the location where high-rate of traffic accidents is observed, even the accidents with the fatalities. Despite the clear horizontal marking, vehicles are crossing into the adjacent lanes, resulting in side collisions. Even the tyre marks are spotted all over the location (Figure 4).

Figure 4. Road deviation at the location of future at-grade intersection area

At this location, not only upgraded signage, but also thorough reconstruction of the roadway is recommended.

Elongating the deviation of the left turn is of utmost importance. As a result, the right edge of the pavement should be displaced outwards. Fortunately, there is a space to slightly widen the pavement and to displace adjacent fill slope.

With the reconstruction of the pavement geometry considered an active measure, that actively increases the safety of the road, some passive measures are to be undertaken as well. These measures assume upgraded vertical signage and improved traffic lane marking (vibro stripes).

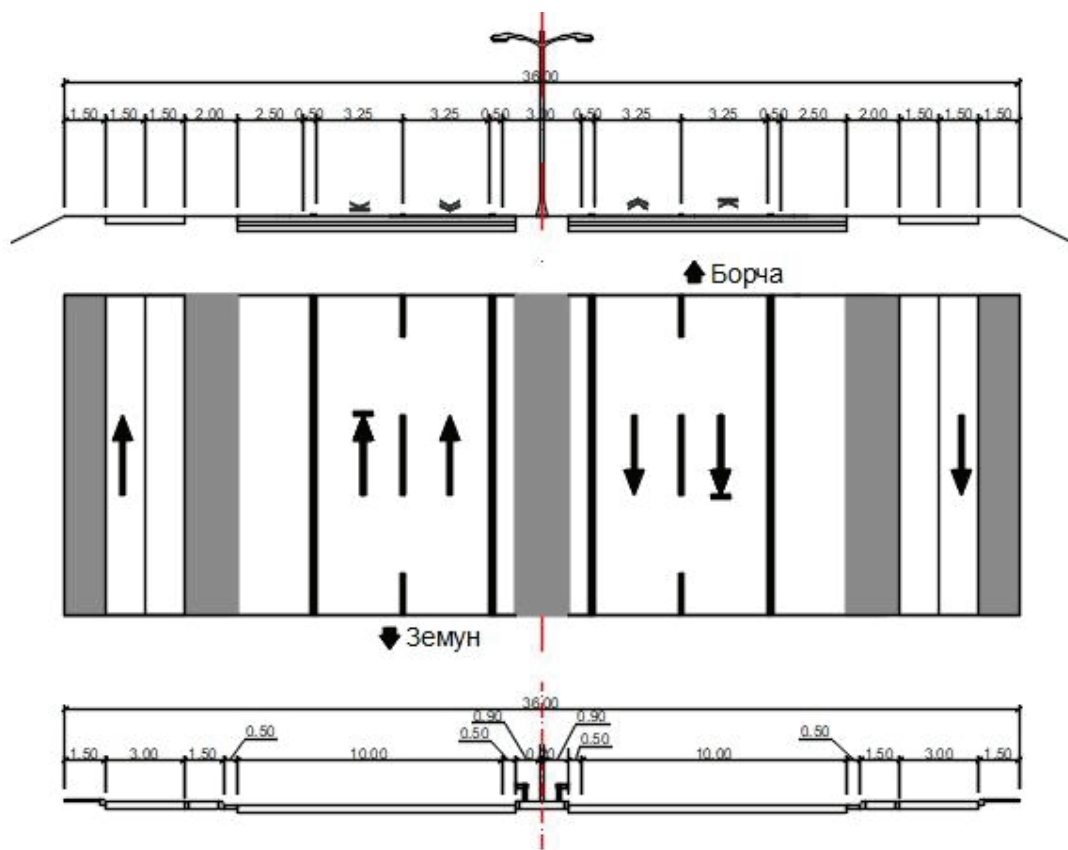
Figure 5. Typical cross section for V=80km/h

Midterm measure, aimed to reduce the speeds down to 80km/h and thus increasing traffic safety, is to reduce the width of traffic lanes to 3.25m. The width of the traffic lane of 3.25 m corresponds to the speed of 80 km/h. According to the regulations, the speed of 80 km/h, requires edge lane 0.35m wide.

As there is enough space for the edge lane of 0.5m, it is on the safe side to adopt that increased width. Since the current traffic flow does not justify 3 traffic lanes per direction, it is proposed to substituted outer traffic lanes with 2.5m wide stop lanes.

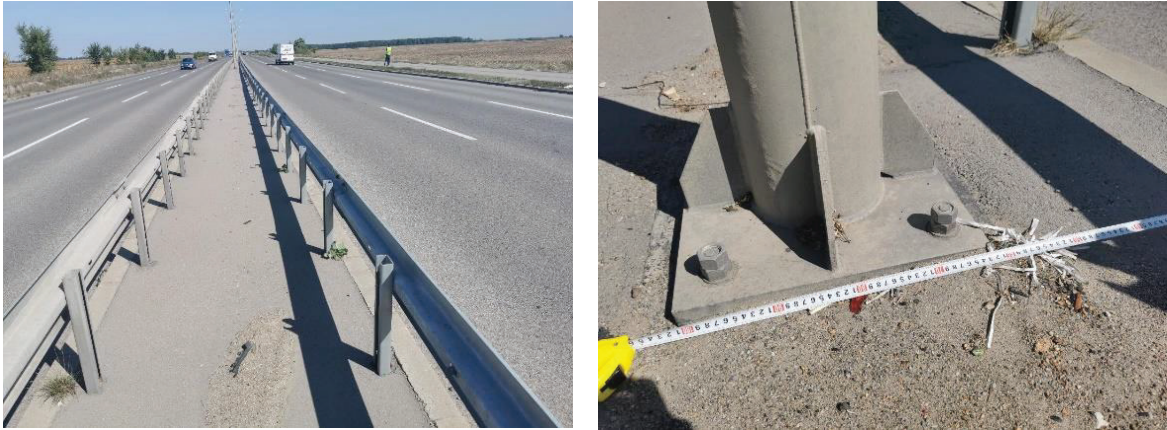
The most critical element of a cross section is absolutely inadequate median width of 2m only. Even the light poles are installed in the median, with the H2W3 safety barriers on both sides. This type of safety barriers is not adequate for a speed of 100 km/h, especially taking into account crush deflection in the light pole zone.

Figure 6. Inadequate median width

The solution to this problem calls for relocating the light poles to the sides, probably in the green belts between the road pavements and walkways. According to the current design practises, this will require curbs that are lower in height (7cm) and safety barriers between the curb and the light poles.

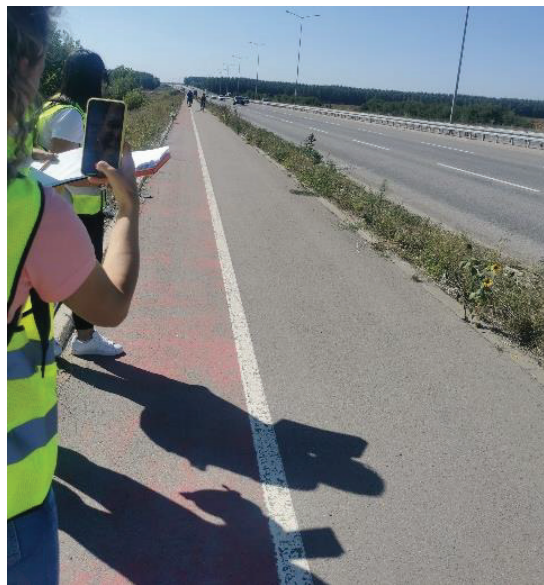
It also apperas that the bicycle path of 1m is not enough and it has been noticed that many cyclists drive into the walkways.

Figure 7. Inadequate bicycle path width

Therefore, it is recommended to rearrange bicycle lanes and adjacent walkways to increase the width of a bicycle lane from 1 to 1.5m. This the minimum for a one-way bicycle path.

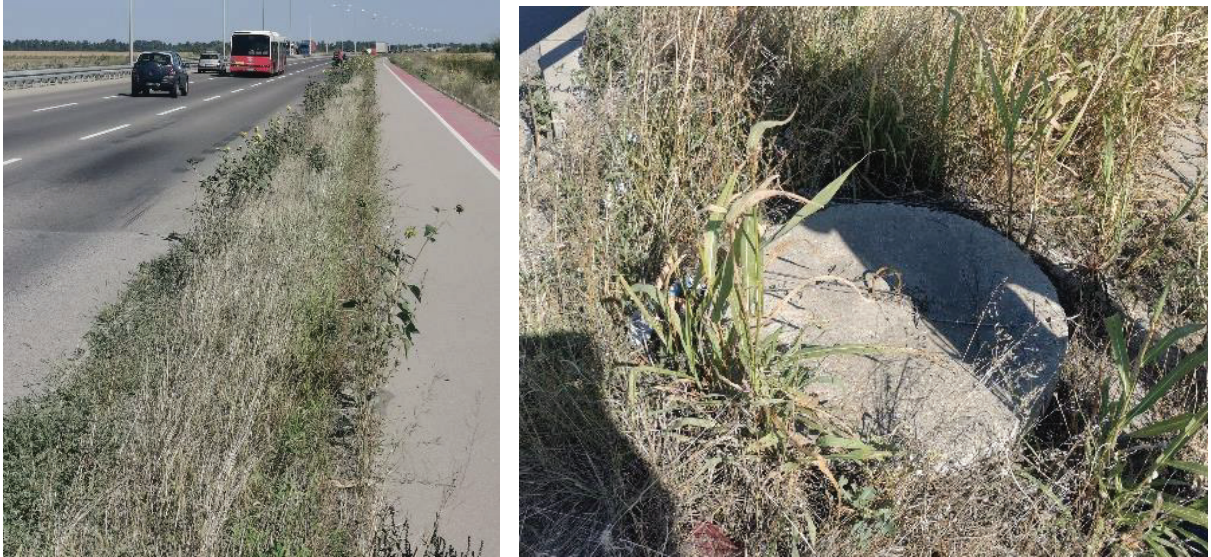
On both sides of the pavement (between the pavement and the walkways) relatively narrow green belts (1.5m wide) are constructed. These green belts are poorly maintained, so the growth even impacts the visibility. What is more important, the debris acumulated in the green belt blocks the water coming from the walkways to the inlets located along the outer edges of the pavement. Poor maintenance in these zone also causes cloging of inlets and the drainage system in general.

Figure 9. Poorly maintained green belt and drainage system

Perhaps, as a long-term measure, complete reconstruction of combined walkways and bicycle lanes that will redirect the waterflow outwards, is proposed. The quantity and the quality of water coming from these surfaces would not hydraulically and environmentally affect embankments and agricultural lands within the corridor. This measure calls for thorough reconstruction of walkways and bicycle lanes, but reduces the load on inlets. What is more, all the material that could clog the inlet, would be redirected to the sides.
