REPAIR OF THE INDOOR SWIMMING POOL TIMBER STRUCTURE

Boško Stevanović¹, Ivan Glišović¹, Marija Todorović¹, Tijana Stevanović¹

¹ Faculty of Civil Engineering, University of Belgrade

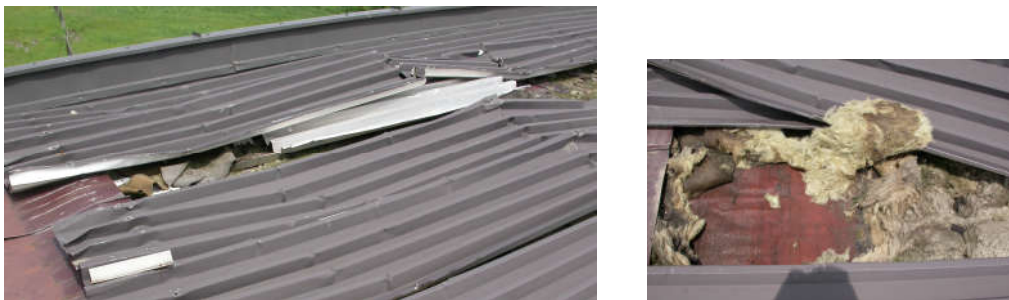
The roof cladding of the facility's main part was extremely damaged, despite the previously implemented repair interventions. Part of the roof covered with profiled metal sheets was completely degraded and no longer fulfilled the function of protection from atmospheric precipitation, nor the thermal insulation function (Figure 2). On the part of the roof covered with flat metal sheets, there was no visible tearing, but there was evident rotting in timber structure and wetting of the thermal insulation, caused by water penetration from the roof part covered with profiled metal sheets. By examining the ceiling surface of the facility's main part, the corrosion in the profiled sheets was observed. The condition of the roof cladding on the annexes, after previous reconstruction of the flat roof, was completely satisfactory.

Figure 2: Roof cladding damages.

Damage to the roof cladding on the facility's main part required radical repair interventions on that part of the roof. These interventions involved a complete removal of the existing roof cladding and all the layers beneath it, and then placing of a new roof cladding (Figure 7). The new multilayer cladding integrated all necessary functions: final protection against atmospheric influences, waterproofing, thermal insulation, vapor barrier and ceiling lining. The application of suitable steel profiles made it possible to obtain air ventilation space. As the last layer of the roof cladding, an aluminium sheet was placed. As a part of cladding works, completely new flashings were made on the connection between roof cladding and exterior walls. For drainage purposes, new horizontal and vertical gutters were made.

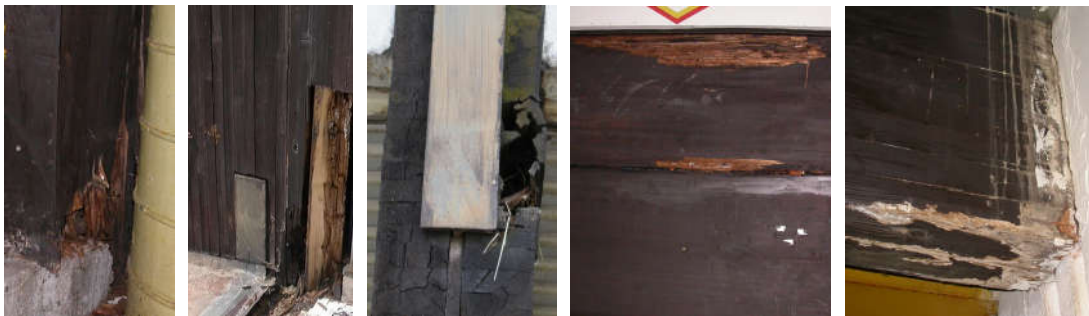
In most cases, the appearance of rot was of local character, but there were also elements that were rotten along their length (Figure 3). The rot was present in several places within the load-carrying roof structure of the facility's main part. Due to adverse unfavourable weather conditions, the overhangs of the main girders outside the facade level had very significant damages. In addition, the main girders were damaged by rot at the supports on the exterior (facade) columns in the F and Z axes. In case of purlins, rot was noted in the end sections, that is, in the support zones on the concrete structure. Columns beneath the main girders in the F axis were damaged by rot to the extent that they had practically lost their load-carrying capac-

ity. Degradation is a result of inadequate protection of facade parts from external atmospheric influences. Columns in the Z axis also had defects caused by rot. This applies to the support zones, both on the lower ends (as with the columns in the F axis), and on the upper ends, where the rot occurred due to water leaking from the roof caused by malfunctioning of the previously present horizontal gutter. On the roof and floor annex beams, rot was mostly located at the supports on the concrete structure, as well as at the points of connection with the columns of the first-floor longitudinal wall, where the end grains were directly exposed to weather conditions. The columns of the annexes also had rot damages on the upper and lower ends.

Figure 3: Rotting of timber elements.

Parts of timber elements with local appearances of rot, which primarily relates to beams and columns support zones, were sealed with the epoxy resin used for injection, with addition of suitable filler. The procedure in question included removing all the rotten parts of "healthy" timber from the damaged zones, placing the appropriate "formwork" around the treated area and then injecting the pre-prepared resin into the space thus formed.

In the case of major damages in form of rotting along the elements, the repair was carried out by "lamination process". This procedure involves removing damaged laminations until "healthy" timber is reached, and then gluing new ones using resorcinol glue. This adhesive is applied in layers with a thickness of 0.3 mm. When "lamination process" is performed it must be ensured that there are no stresses in the bonding planes.

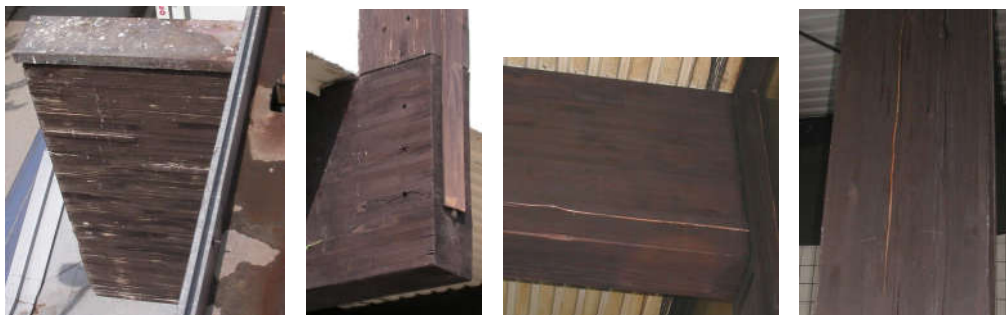
One of the most noticeable defects in timber structure was the appearance of smaller or larger fractures and cracks (Figure 4). These cracks were mainly in the direction of wood grain and were mostly caused by thermo-hygrometric factors, especially in the case of cracks on the overhanging parts of the main girders. These elements were directly exposed to atmospheric influences and temperature changes. The appearance of horizontal cracks primarily in the support zones was registered in the annex beams. Similar damages were noted in the columns of the main part and the annexes.

Figure 4: Appearance of fractures and cracks in timber elements.

Cracks in timber beams were injected with a two-component epoxy resin of appropriate viscosity and physical-mechanical properties. The injection was preceded by preparation which involved cleaning the cracks, sealing the cracks with an epoxy kit and inserting inlets for resin injection.

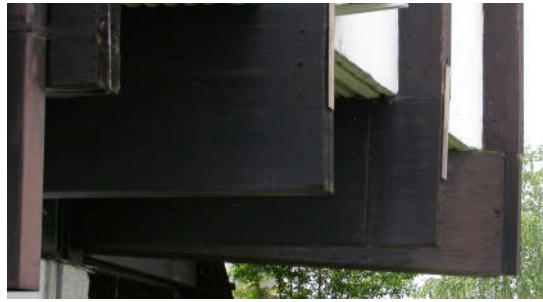
Significant damages to timber structure were also deformations (deflections) of the members, as a result of rheological characteristics of wood. The deflections were particularly large in the overhangs of annex floor beams and could be clearly seen without measuring with geodetic instruments (Figure 5). Measured deflection values of these beams were 5-6 cm.

Figure 5: Deflection of the floor beams overhangs.

In order to reduce the extremely large deflections of the annex timber structure, new square hollow profile steel columns were inserted on the first floor at the positions of timber columns on the ground floor (Figure 8). These columns were at the bottom end anchored into the concrete slab laid over profiled steel decking, while on the upper end they were appropriately connected with the existing roof beams. As some of the added columns were positioned within the existing partition walls (brick, plasterboard, etc.), in these places double HOP columns were designed on both sides of the partition walls.

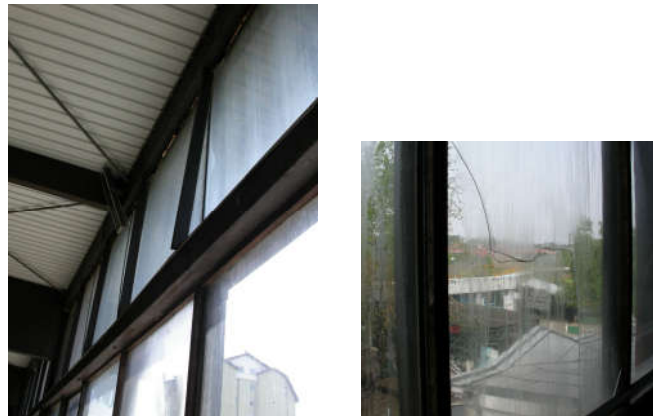
Condition of the glass facade was a great danger to public's safety, as there was a possibility of individual facade segments failure and glass surfaces falling off (Figure 6). Facade beams have suffered major damages in form of rot and larger cracks. In addition, some beams had very large deflections. The earlier intervention in terms of inserting additional short columns was not completely successful.

Figure 6: Damages to the glass façade.

Since the existing horizontal and vertical timber elements within the longitudinal facades of the facility's main part were no longer able to perform structural load-carrying function, the entire glass surfaces were repaired or replaced. The repair intervention on the facade in the Z axis involved the production of new facade beams with new columns in accordance with the existing state (see Figure 10). The new glass facade was embedded in spaces surrounded by the existing columns of the roof structure. This facade was made of aluminium structure with thermal insulation glass, with corresponding number of windows that have a possibility of opening for ventilation of the facility. Within the facade in F axis, which was previously

closed with profiled sandwich panels, the installation of a new glass facade was planned. In order to allow the insertion of this facade, a construction of new steel lattice girders above the existing facade beams was carried out (see Figure 10). In the areas that were formed by the existing columns of the roof structure, the upper edge beam and, on the lower part, the steel lattice, aluminium structure of the facade with thermal insulation glass was inserted. Also, on this facade, there is a number of windows with a possibility of opening for ventilation of the interior space. The final works on this facade included covering with profiled steel sheets with thermal insulation of parts above and below glass surfaces, as well as parts in the column zones. In the interior of the facility, area between the glass surfaces of the facade (between the columns) and the floor (stands) was covered with plasterboards.

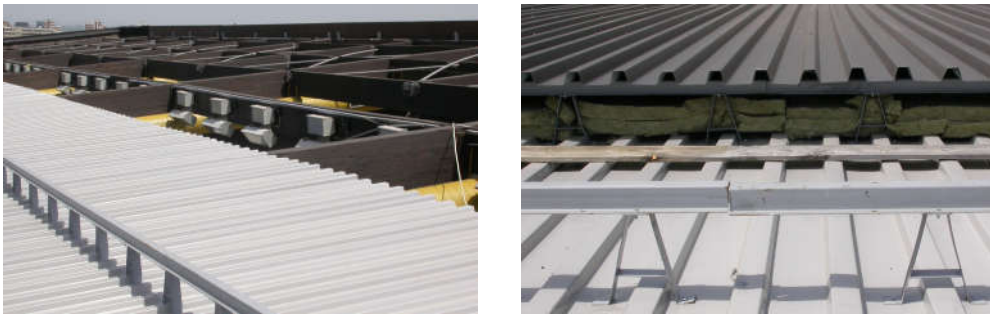
Figure 7: New roof cladding positioning.

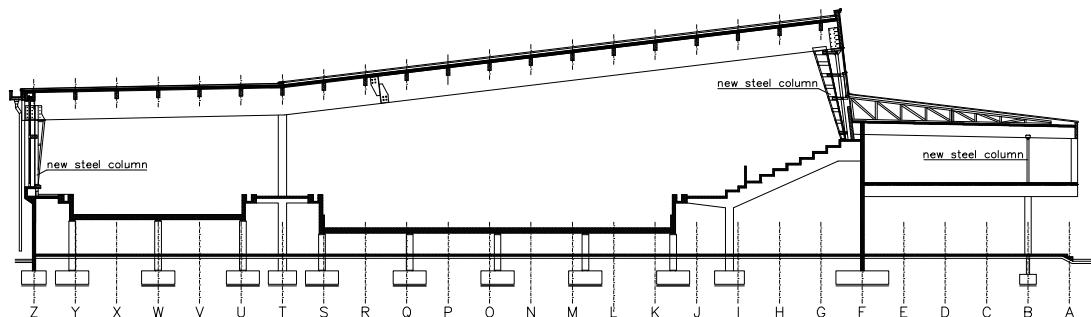
Figure 8: Position of new steel columns as a reinforcement of existing timber structure.

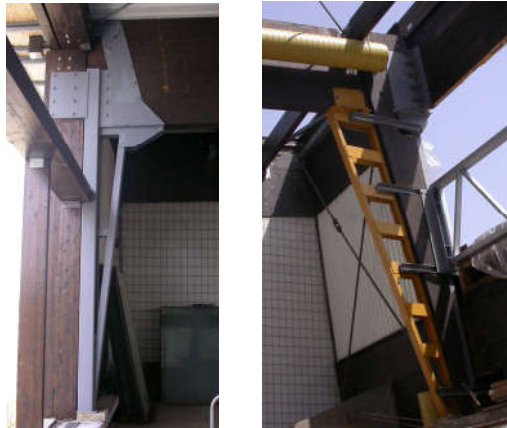
Figure 9: New steel columns next to the existing timber columns in Z axis (left) and F axis (right).

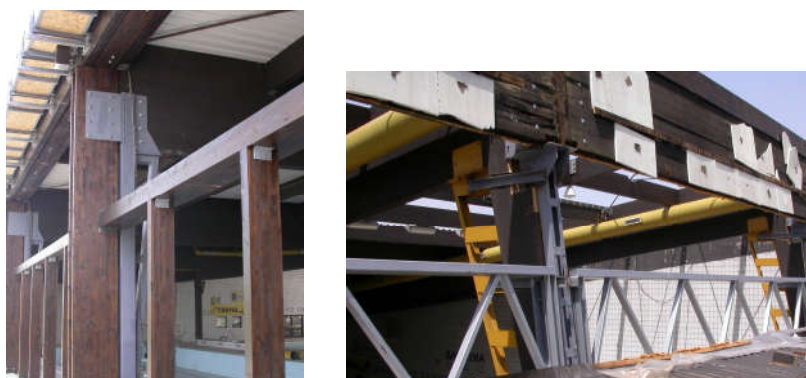
Figure 10: Elements of the new glass facade structure in Z axis (left) and F axis (right).
