Marko Marinković¹, Svetlana Brzev², Nemanja Krtinić³, Željko Žugić⁴

SEISMIC PERFORMANCE OF SCHOOL BUILDINGS IN RECENT EARTHQUAKES: LESSONS FOR SERBIA

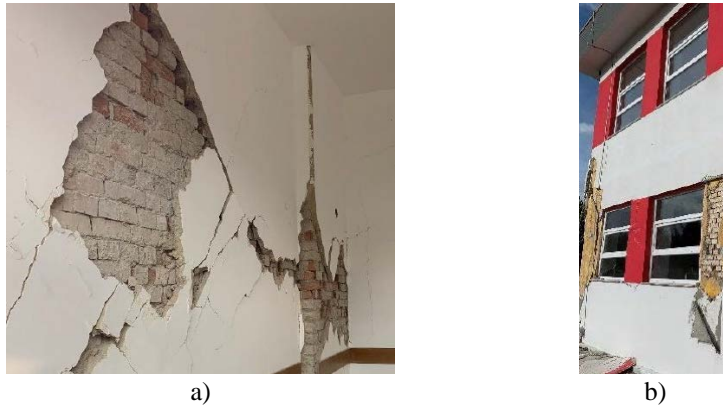
A two-storey unreinforced masonry (URM) school in the Thumanë village (Figure 1) was severely damaged (note that in the same village two low-rise URM apartment buildings collapsed). The school was built in the 1970s and it was recently refurbished. Building damage at the exterior was not visible, however a heavy damage was observed in the interior, with diagonal cracks and failure of loadbearing URM walls and masonry piers in walls with opening. The building was determined to be unsafe and had to be demolished. Several other URM school buildings experienced damage at the slab-wall connections, indicating risk of potential out-of-plane wall collapse. Other damage patterns, such as light cracking of masonry walls and plaster, damage of parapets and other non-structural elements, were also widespread in schools in Albania.

Figure 1 – Damage of a school building in Thumanë, Albania: a) failure of the loadbearing URM wall and b) damaged masonry piers [6]

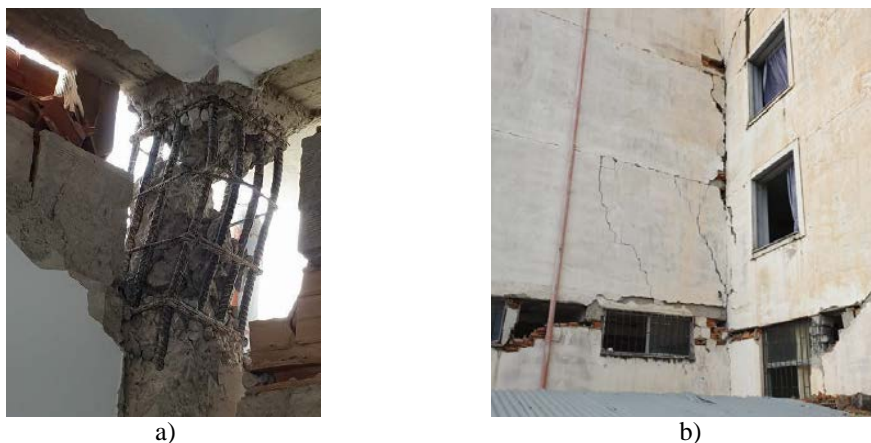
Figure 2 – Damage of a school building in Maminas, Albania: a) failure of the RC column and b) damaged masonry infill walls [6]

Damage of reinforced concrete (RC) school buildings was similar as damage observed in residential buildings of the same typology. These buildings experienced mostly non-structural damage to masonry infills and partition walls. For example, excessive lateral deformations occurred at the ground floor level in the school building in Maminas, causing extensive damage of exterior RC columns (Figure 2a). These columns were subjected to a high displacement demand, but the detailing was inadequate: the ties had 90 degree hooks and failed to provide required confinement. Furthermore, infill-frame interaction contributed to higher seismic demand in the columns as well as infill walls and caused failure and heavy non-structural damage in these elements (Figure 2b). Another school, Neim Babameto in Durrës, had a RC moment frame system consisting of columns and beams with a “strong beam-weak column” configuration, which was one of the causes of severe structural damage as well as infill failures.

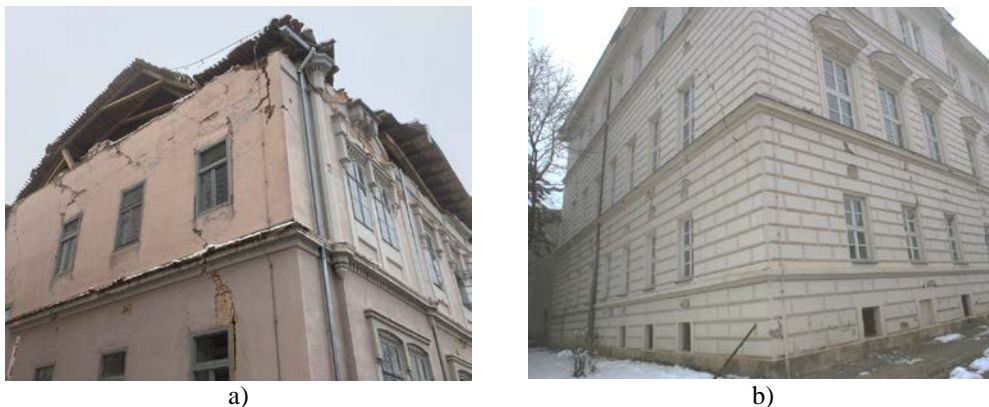
Figure 3 – Damage of URM schools in Petrinja, Croatia: a) exterior damage of the First school building and b) inclined shear cracks in the walls of the Petrinja High School

Structural system of the First Primary School in Petrinja, which was built at the beginning of 20th century, consisted of URM walls and jack arch floor slabs (known as *Pruski svod* in Serbian). The building had a timber roof with clay tile roofing, which partially collapsed (Figure 3a). The building also experienced significant non-structural damage, especially in the interior partition walls between the classrooms which were severely damaged due to

inadequate slab-wall connection. Another school in Petrinja, Petrinja High School, was a massive URM building constructed in 1860, and experienced extensive damage in the form of inclined shear cracks in the loadbearing walls (Figure 3b). It could be observed that cracking in exterior walls above the windows was less pronounced, but the reported interior damage was so severe that the building was classified as unsafe for entry.

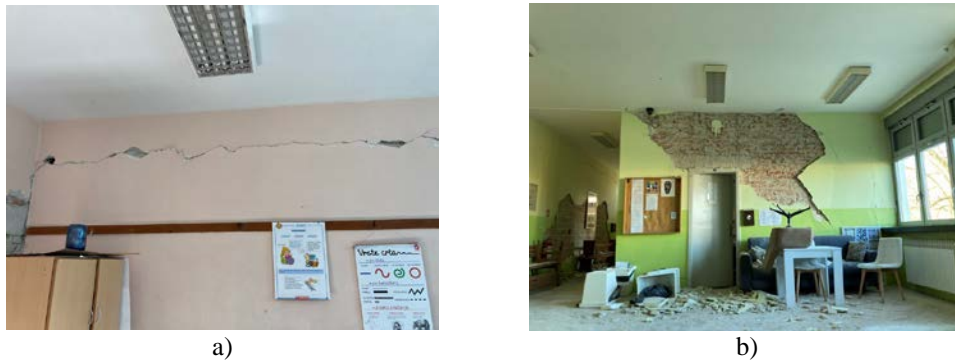
Majority of RC school buildings in Petrinja experienced minor structural damage, however non-structural damage was severe. Elementary school Dragutin Tadijanović, built in 1974, is a masonry-infilled RC moment frame structure with an irregular plan shape. The building did not experience structural damage, but several infill walls experienced long cracks along the infill-frame interface (Figure 4a). Another educational building, Faculty of Education, was built in 1962 as an RC frame building with masonry infills. The infill walls were severely damaged due to in-plane seismic effects, with diagonal cracks in the walls (Figure 4b) and along the infill-frame connection. Out-of-plane displacements were observed in several infill walls. Furthermore, a ceiling collapsed in one of the classrooms.

Figure 4 – Damage of RC schools in Petrinja, Croatia: a) cracks at the infill-frame interface, school Dragutin Tadijanović and b) damage of infill walls and plaster spalling, the Faculty of Education

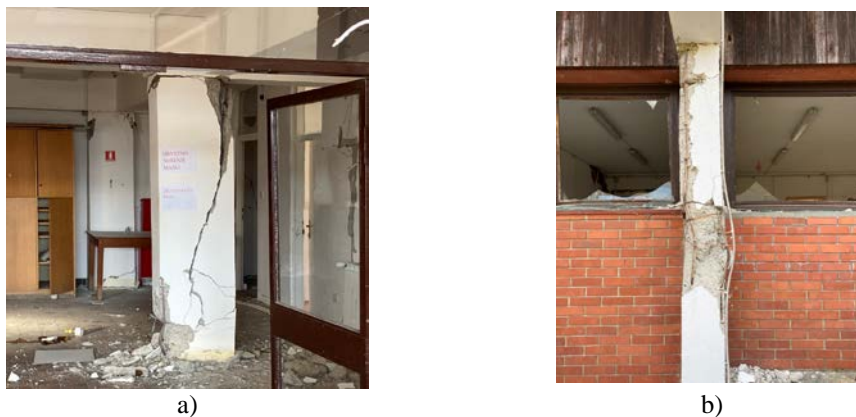
Figure 5 – Damage in the former elementary school in Donja Bačuga: a) shear failure of an interior column and b) a “short column” failure of an exterior column

Former elementary school in Donja Bačuga is currently the Centre for Plum and Chestnut, an educational institution for agriculture, has an RC moment frame system with masonry infill walls, and experienced severe structural damage in the earthquake. Interior columns had 55x30cm cross-sectional dimensions (longer dimension was aligned in transverse direction) and experienced shear failure, as shown in Figure 5a. The building survey showed that ties were provided at 20 cm spacing in interior columns and at 30 cm for exterior columns. Excessively large tie spacing and interaction between partial-height infill and the frame in exterior columns caused a “short column” effect (Figure 5b). Almost all infill walls in the building experienced severe cracking in the walls and horizontal cracks at the infill-to-top beam interface.

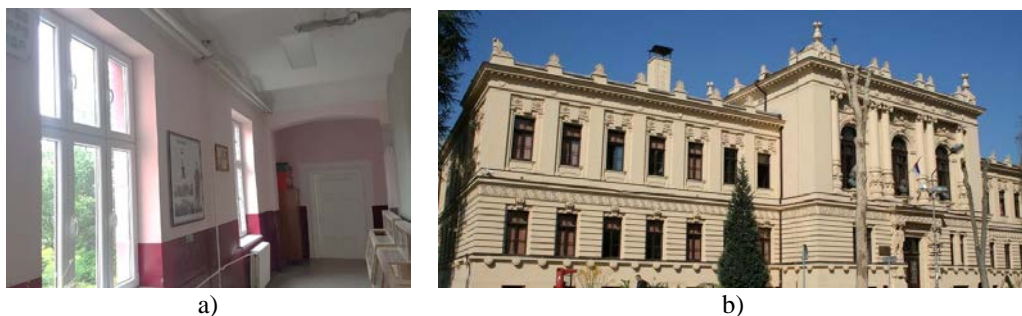
Figure 8 – URM schools in Serbia: a) Primary School Milisav Nikolić in Malo Crniće and b) High School in Valjevo

(Figure 6b), as it was the case with the highly damaged First Primary School in Petrinja (Figure 3a). One example is Primary School Milisav Nikolić in Malo Crniće (Figure 8a), built at the same time and in the same structural type (URM walls and jack arch floor slabs, known as *Pruski svod* in Serbian). Petrinja earthquake also showed what could be expected with the massive URM building of High School in Valjevo (Figure 8b) and similar, since it was built at the same time and with an identical structural type as Petrinja High School (Figure 3b).

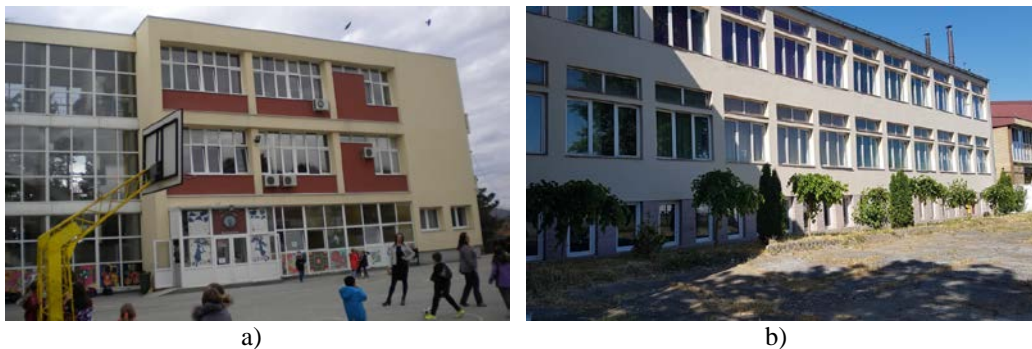
The results of the survey showed that the most common structural type of schools in Serbia is RC frame (Figure 6b and 7b). Frames are always filled with masonry infill walls. Furthermore, the biggest number of the RC framed schools is built between 1960 and 1970. In exactly the same period as damaged school buildings in Petrinja, (Figure 4 and 5). Since at that period Serbia and Croatia were part of the same country (Yugoslavia), it is for sure that the same materials and construction practice were used in building these schools both in Serbia and Petrinja. Therefore, the performance of the damaged schools in Petrinja can serve as an example what can be expected in Serbia. Some representative examples of the schools from Serbia matching the damaged ones from Petrinja are Primary School Sveti Sava in Mladenovac (Figure 9a), Primary School Slavko Rodić in Sečanj (Figure 9b) and others.

Figure 9 – Infilled RC frame schools in Serbia: a) Primary School Sveti Sava in Mladenovac and b) Primary School Slavko Rodić in Sečanj
