GEOTEHNIČKI UZROCI OŠTEĆENJA DOMA NARODNE SKUPŠTINE U BEOGRADU

GEOTECHNICAL CAUSES OF DAMAGES FOR THE PARLIAMENT BUILDING IN BELGRADE

STRUČNI RAD
UDK: 624.131.5.042 = 861

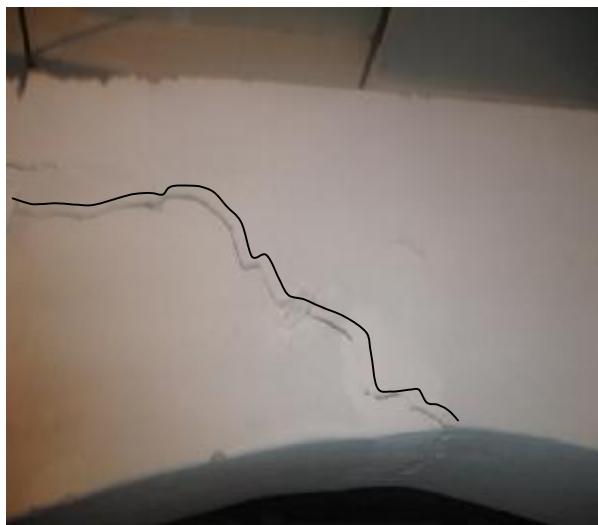
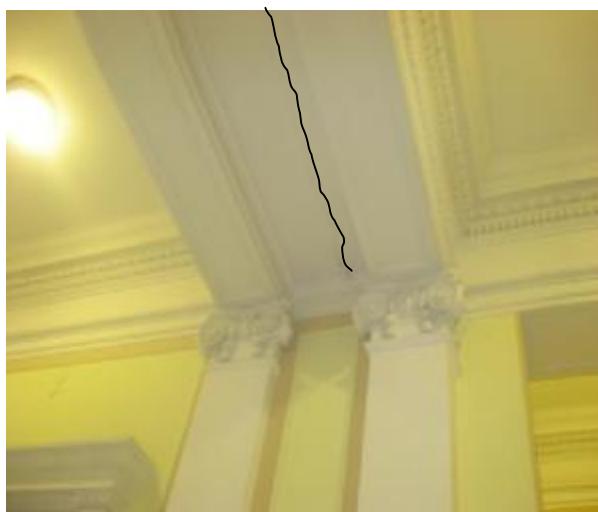
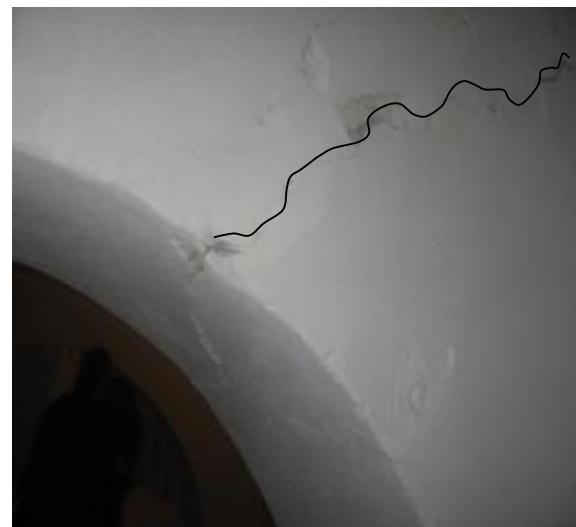
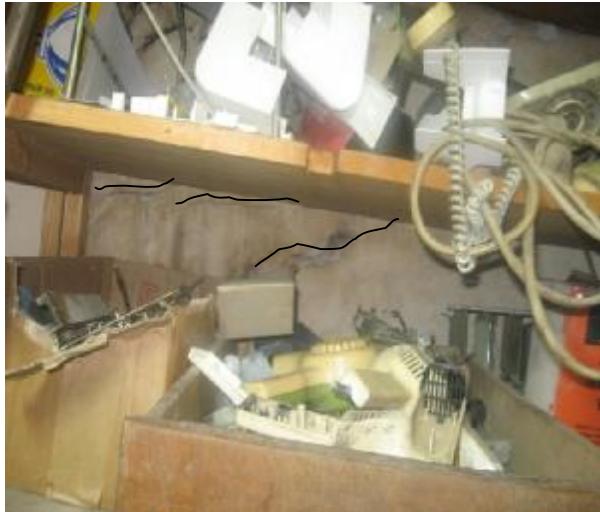
*Slika 2. Oštećenja u Domu Narodne skupštine
Figure 2. Damages in the Parliament building*

Sleganja terena na koti fundiranja, koja su nastala od opterećenja objekta su veća od dozvoljenih i konstruktivni sistem objekta, svojim elastičnim kapacitetom nije mogao da ih prihvati i podnese bez oštećenja. Samim tim, u zonama gde je bila iscrpljena nosivost konstrukcije, pojavila su se oštećenja koja su se manifestovala kao prsline, pukotine i slični diskontinuiteti na samom objektu, slika 2.

Posebno treba naglasiti negativan uticaj raskvašavanja lesnih naslaga ispod temelja koje dovodi do dodatnih sleganja objekta. Ovo izaziva ugaonu rotaciju delova objekta, oko mesta provlažavanja, koja je znatno veća od dozvoljene, a što neizbežno dovodi do novih oštećenja objekta. Ovo je karakteristično za mnoge stare zgrade u Beogradu.

Ground settlements at a footing level, arising from the building load and increase of soil moisture are larger than allowable values. Thus, the building structural system with its elastic capacity was not able to accept and submit these settlements without damages. Therefore, in places where construction capacity was exhausted, appeared the damages that were manifested as cracks, crevices and similar discontinuities on the some parts of construction, Fig. 2.

The negative impact of later soil moisture increasing on loess deposits underlying the foundation should be emphasized as well. It produces subsequent subsidence of the building. Additional settlements lead to the angular rotations of some parts of the building around the site of the increase of soil moisture which were significantly higher than the allowable values, and inevitably cause the additional damage of the building [5]. It characterizes many old buildings in Belgrade.

Despite the observed damages and deficiencies, the Parliament building is in operation. It serves to its purpose and it is in use without any problems. To retain this status in the future, it is necessary to take action and intervention to the building construction system as well as to the foundation structure. These actions and interventions should prevent further spread of damages and should preserve the integrity of the whole building. Therefore, from the geotechnical point of view, some solutions of remedial measures are considered: strengthening of foundation structure with micropiles, diaphragms, or with combination of micropiles and diaphragms.

Applying the system of micropiles would prevent additional settlements, but it would not increase the ability of structure to receive the horizontal seismic forces. Besides, subsequent leaching of loess deposits in the foundation soil could reduce the bearing capacity of micropiles. This would cause additional settlements of the building.

Rehabilitation of foundation structure using diaphragms would produce the dynamic stability of the structure as well as its safety in regard to the fluctuations of groundwater levels. However, due to exceptional indentation of the building, it is not possible to make diaphragms in all relevant areas within the object.

Therefore, it was proposed that rehabilitation of the foundation system can be performed using the suitable combination of micropiles and diaphragms, with additional appropriate interventions in the building structure system (Faculty of Civil Engineering, University in Belgrade, 2010).

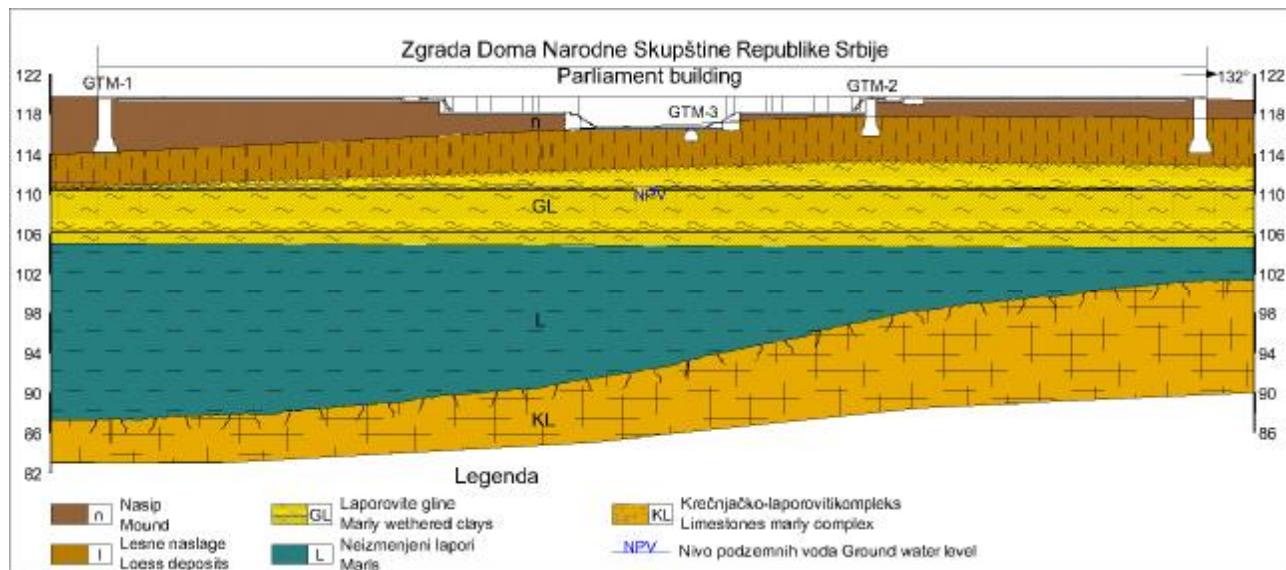
Slika 4. Geotehnički presek terena
Figure 4. Geotechnical cross-section of terrain

Foundation strips, for the most part of the Parliament building, are placed in the loess deposits, except for a small part of the ground beneath the southeastern part of the building, towards Boulevard King Alexander, where the footing level is in the contact of loess deposit and marly clay.

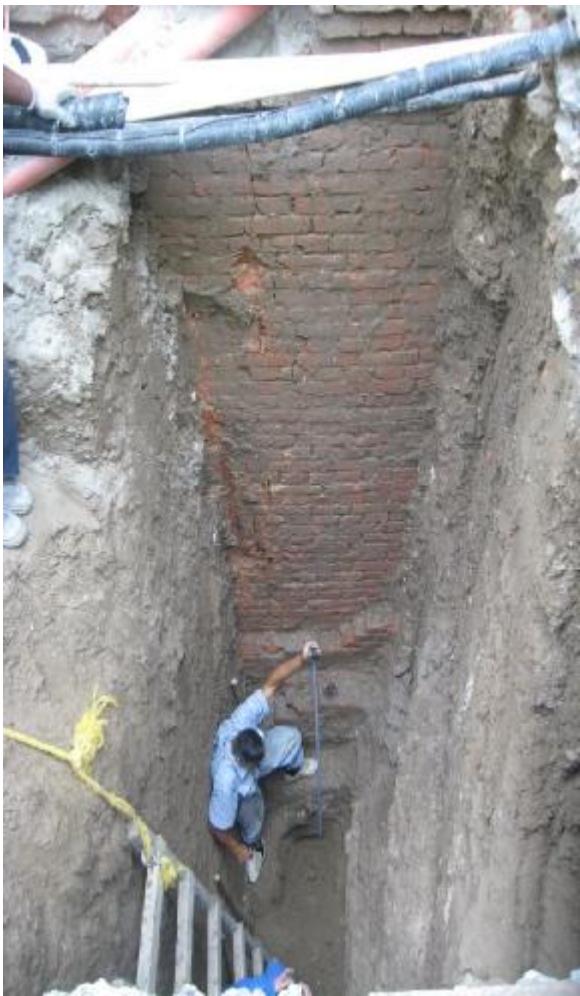
Slika 5. Utvrđivanje dimenzija temelja u jami J-1
Figure 5. Measuring foundation dimensions in trial pit J-1

– T_1 , the external footing strip (the excavated trial pit J-1 in the western part of the building) has a width of $B_1=2.30m$ and it is founded at a depth of 5.50m below the surface of the pavement (level 119.57m, $D_{f\min}$ = minimum depth of foundation = 5.50m).

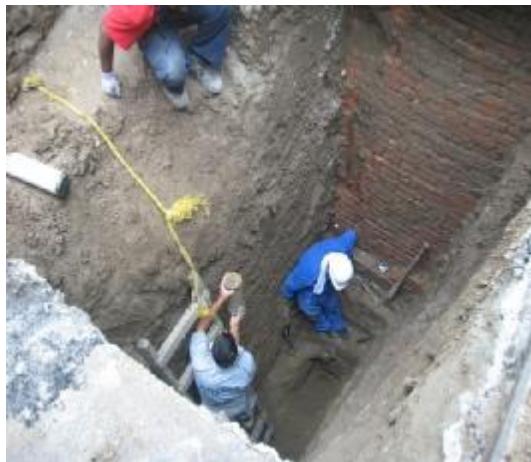
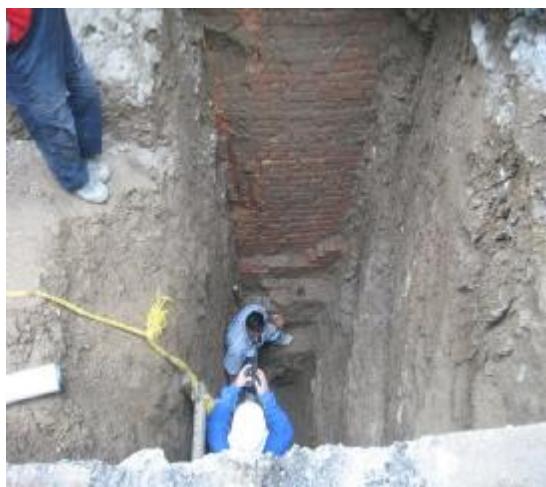
Slika 6. Uzimanje uzorka tla ispod temelja u jami J-1
Figure 6. Sample extracting from trial pit J-1
