METHODOLOGY FOR STATISTICAL ANALYSIS OF SQUAT RAIL DEFECTS

Abstract – This paper proposes a methodology for statistical analysis of data obtained by visual inspection of squat defects on the rail head. Rail inspection by visual observation, including measurement of the squat defect position and depth was performed in Pančevo Varoš railway station in 2017. The obtained data about the squat rail defect (defect type 227 according to the UIC 712) on the main tracks was analysed in this paper. The rail defect position was determined regarding the position of the nearest sleeper in the track. Statistical analysis of the occurrence of squat rail defect was conducted according to the performed visual inspection in the field. Statistical data processing was performed for tracks zones according to the vertical stiffness of rail support. Furthermore, the impact of traffic load, the type and the arrangement of sleepers on the appearance of the squat rail defect was considered.

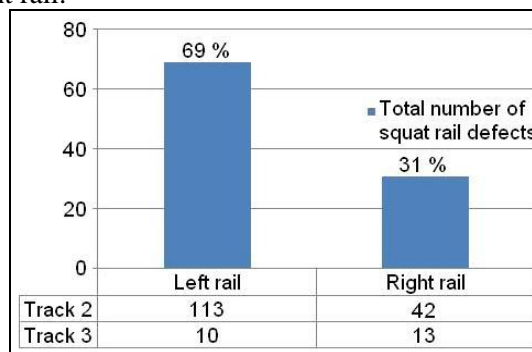
Fig.5. Distribution of squats on rails

The total number of squat rail defects on the left and right rails in the second and third tracks is shown in Figure 5. It was observed that the left rail of the second track is significantly more damaged than the right rail.

It is interesting to note that the left rail is significantly more damaged than the right rail on both tracks. Wooden sleepers are located in the zones of switches at the beginning and at the end of railway station, while the zones II and III contain concrete sleepers. By comparing zones with wooden and concrete sleepers, it can be concluded that the percentage of squat rail defects is significantly higher (more than 3 times) on the rails above the concrete sleepers. This is closely related to the rail support stiffness.

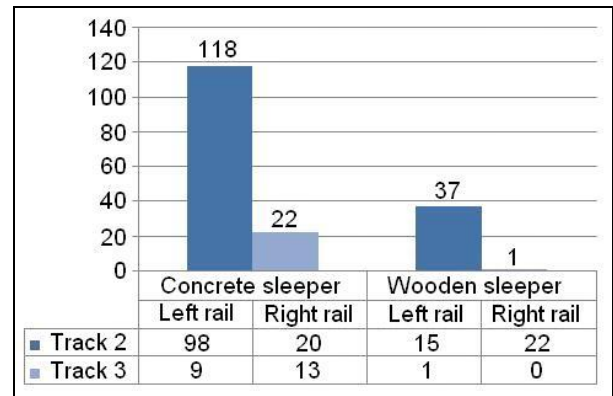
Fig.9. Distribution of squat rail defects in zones with concrete and wooden sleepers

Figure 9 shows statistical data on the total number of squats observed on the tracks No. 2 and No. 3 in zones with wooden and concrete sleepers (zones II and III). According to the total number of detected defects, a significantly greater number of squat defects was observed in zones with concrete sleepers.

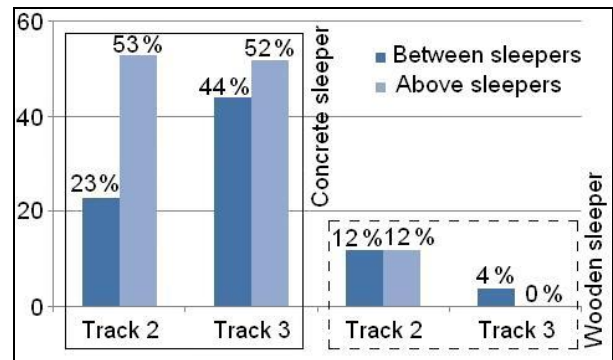
Fig.10. Distribution of squat rail defects occurring between and above concrete and wooden sleepers

The visual inspection showed a higher percentage of squat occurrences in the zones above the concrete sleepers for both tracks (Figure 10).
