GEOTECHNICAL ASPECTS OF CIVIL ENGINEERING AND
EARTHQUAKE ENGINEERING - Vrnjačka Banja, 01-03. novembar 2023.

Svetlana Brzev¹ and Marko Marinković²

PERFORMANCE OF REINFORCED CONCRETE BUILDINGS IN THE
FEBRUARY 6, 2023 TÜRKIYE EARTHQUAKES

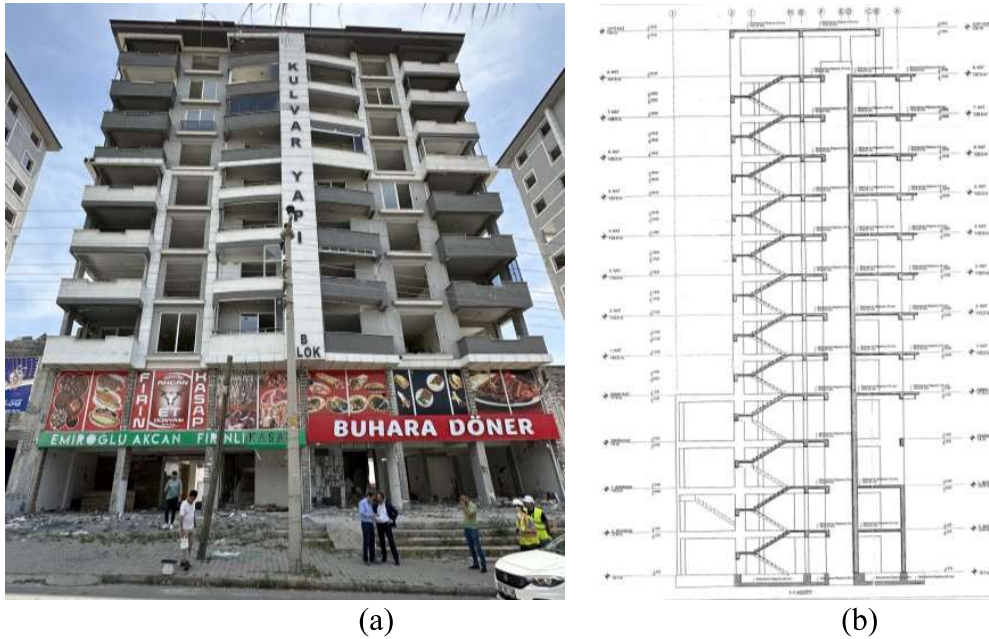
A few design- and construction-related deficiencies were observed in the buildings which were surveyed by the authors. The buildings were designed in 2016 as a part of the building complex consisting of four building blocks (A, B, C, and D) - see exterior view in Diagram 7a. The building has 11 floor levels, out of which the bottom 4 levels have a larger plan shape and there are no masonry infills, therefore the bottom portion acts like a podium that supports the more narrow upper portion of the building (Diagram 7b). It should be noted that podium portion of the building was laterally supported in the E-W direction on each side by the adjacent structures (seismic gaps between the building

blocks were specified by the construction drawings but were not implemented). Also, the bottom two storeys of the podium were buried (earth-supported) on the north side.

Diagram 7. An example of a high-rise RC building, Kahramanmaraş: a) exterior view, north façade, and b) an elevation showing N-S direction (note the podium).

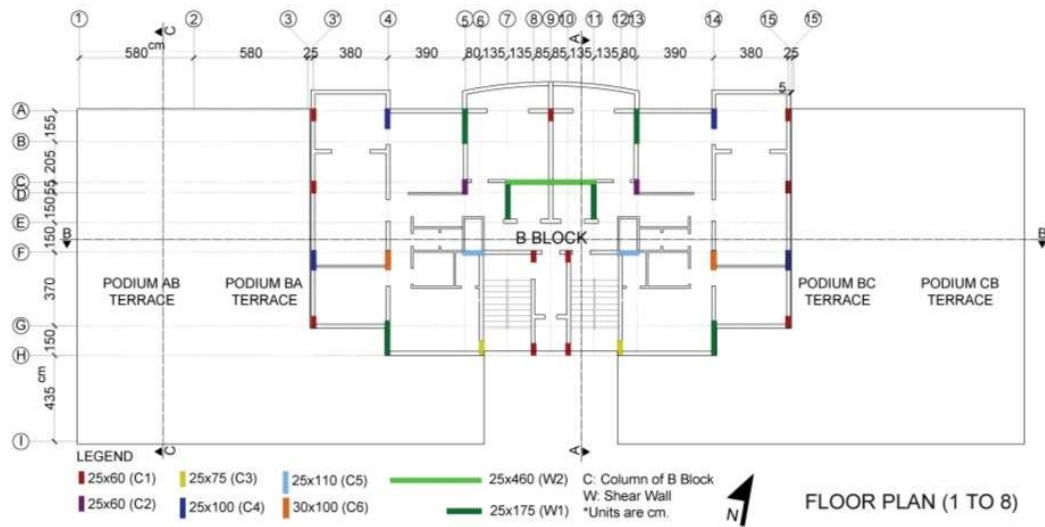
Typical floor plan for the upper portion of the building (above the podium) is shown in Diagram 8. Based on the information provided on the construction drawings, the building was designed as a dual frame-wall structure for seismic design purposes. However, besides the C-shaped elevator core which acted like a complex structural wall, there were no additional walls in E-W direction, and only 6 short structural walls (25 cm x 175 cm thickness x length) were constructed in the N-S direction. The 2007 seismic design code did not clearly prescribe the minimum amount of walls and their contribution to the overall lateral load resistance, which is believed to be an omission in the code.

An additional factor contributing to excessive lateral flexibility of the structure, particularly in the E-W direction, was an asymmetrical column layout. It can be seen from the floor plan (Diagram 8) that majority of the columns were aligned in the N-S direction, but only 4 columns along the exterior gridline on the north side plus two additional interior columns were aligned in the E-W direction. The columns have an elongated rectangular shape, with 25 cm width and the depth ranging from 60 to 100 cm. It is expected that majority of the columns resist seismic effects in E-W direction by weak axis bending, which is undesirable.

Diagram 8. An example of a RC building, Kahramanmaraş – typical floor plan for the floor levels above the podium (credit: Şerife Özata).

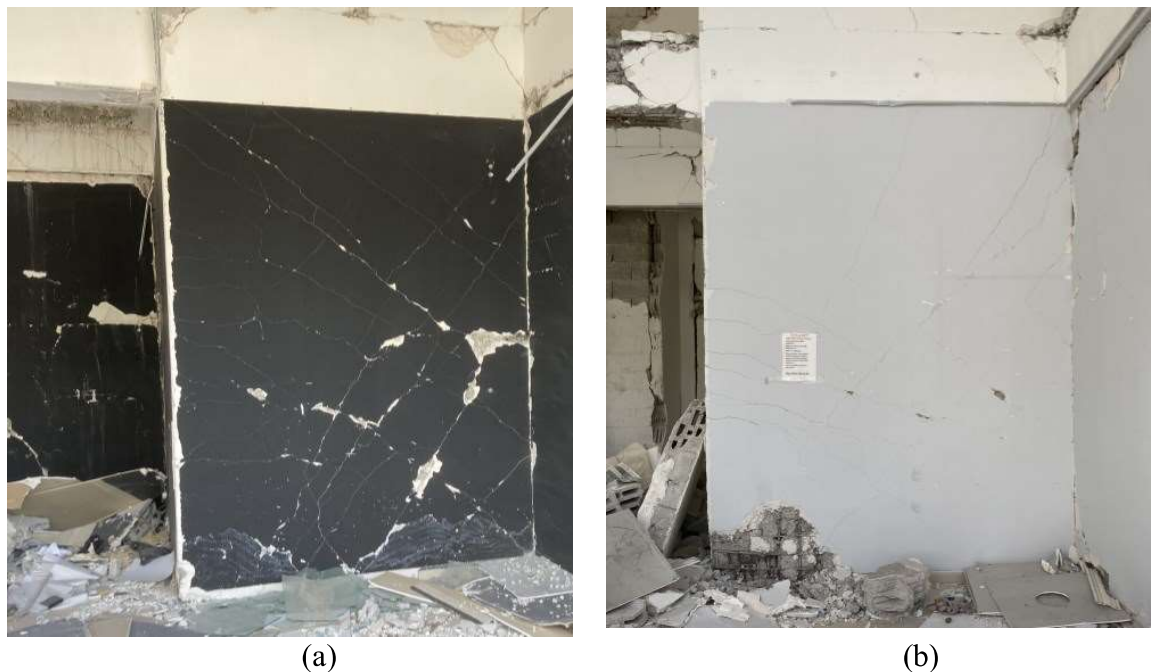
These buildings experienced only moderate structural damage, however non-structural damage was extensive. Structural damage in the elevator cores, as observed at the ground floor level, was mostly in the form of shear cracking or damage due to the combined axial load and flexure, as illustrated in Diagram 9.

Diagram 9. Structural damage in an elevator core: a) shear cracks (Block C) and b) damage at the base of the wall due to buckling of longitudinal reinforcement caused by overturning moment (note absence of cross-ties)

It should be noted that the detailing of reinforcement for the elevator core was not implemented according to the construction drawings. One of the important deficiencies is

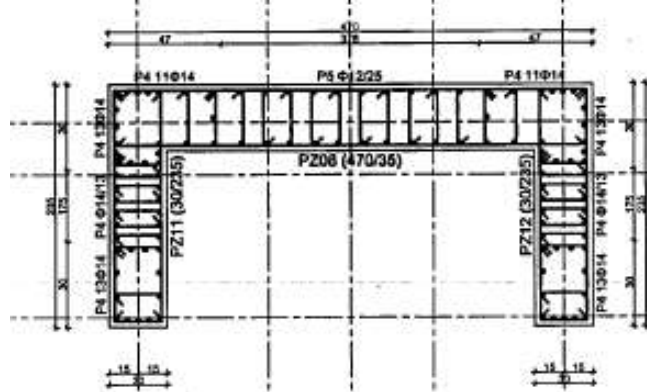
related to the absence of cross-ties, which have important role in preserving the integrity of reinforcement cage in shear walls and columns. Absence of cross-ties in RC shear walls and columns was observed in many surveyed buildings. Reinforcement detailing for the elevator core (as specified on the construction drawings) is shown in Diagram 10.

Diagram 10. Reinforcement details for the elevator core (note closely spaced cross-ties indicated on the drawing)

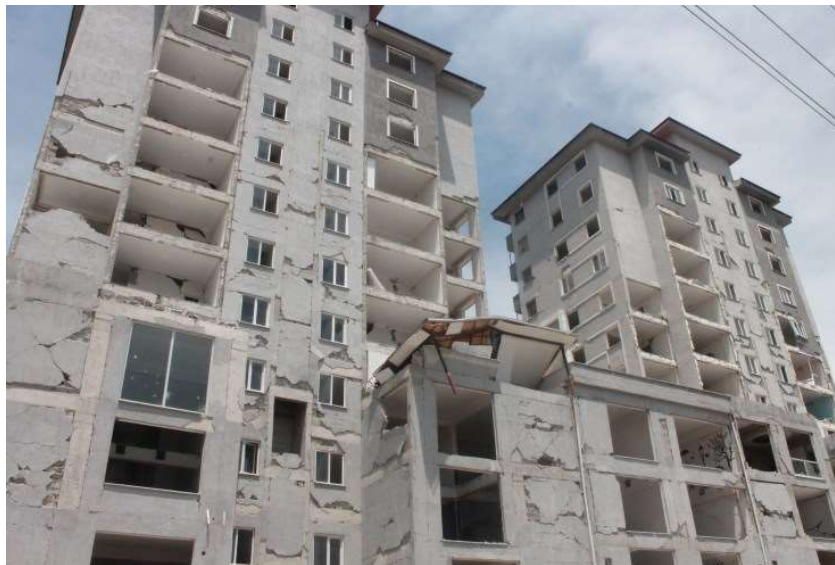
The most significant consequence of excessive structural flexibility was a non-structural damage of infill walls and partitions. In particular, exterior infill panels on the south façade of the building experienced significant damage, and many infills entirely collapsed (Diagram 11). Many interior infills and partitions experienced cracking, and/or portions of the infills fell out of the frame (Diagrams 12a and b). The infills were made of lightweight concrete blocks (known as bimsblock or bricket in Türkiye), and the extent of damage could be partially attributed to their low compressive strength (on the order of 2MPa). A typical masonry element (block) is shown in Diagram 12c.

Diagram 11. Failure of exterior masonry infills was observed in all building blocks

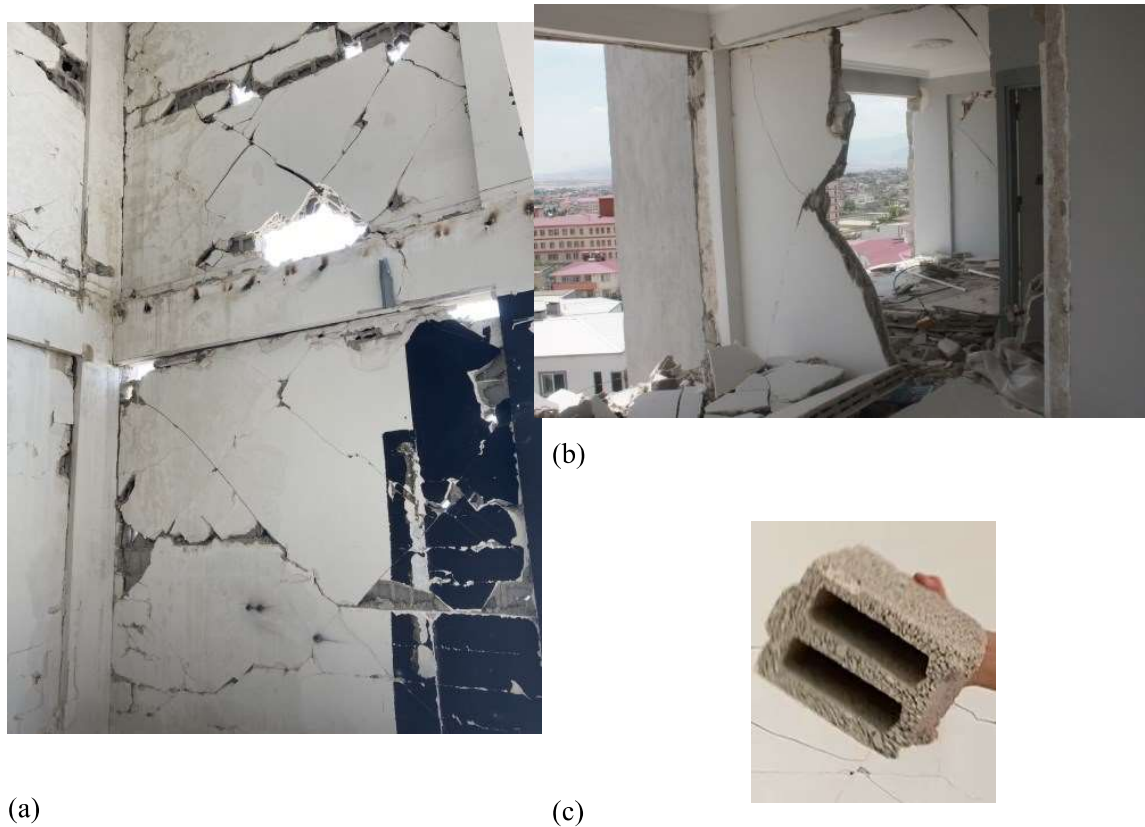
Diagram 12. Non-structural damage of masonry infill walls and partitions; a) extensive cracking of exterior masonry infills and separation from the frame – ground floor level; b) failure of both interior and exterior infills at the upper floors, and c) a typical masonry block.

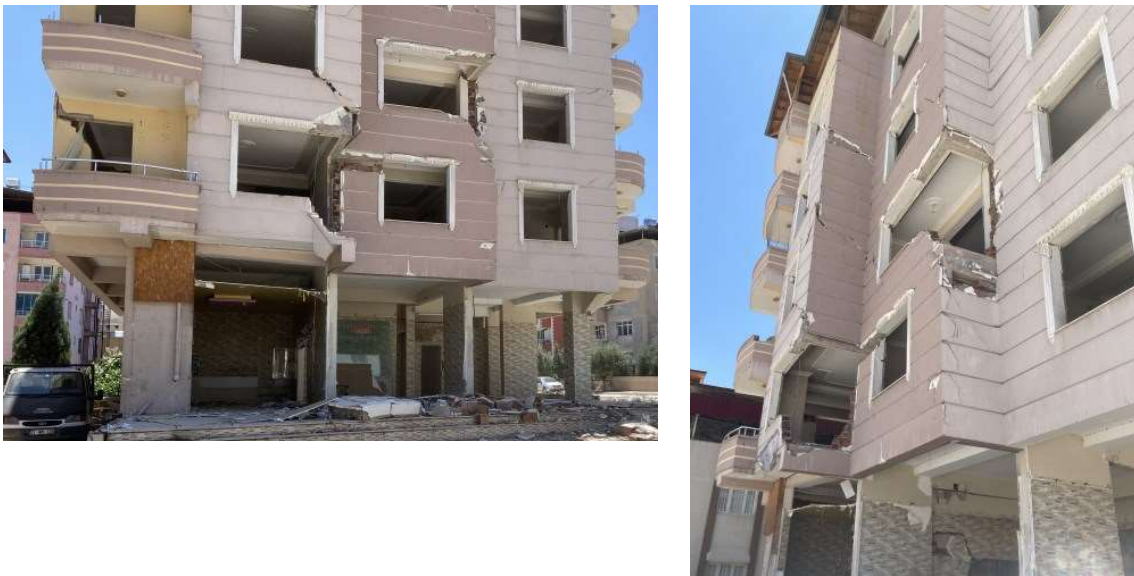
Another cause of non-structural damage in RC buildings was related to overhangs, that is, an increase of the floor area above the ground floor level (see Diagram 13). Overhangs at the upper floors are created when floor slabs project outwards from the exterior column axes. These overhangs cause a difference in stiffness and mass between the ground floor and upper floors (a vertical irregularity). Post-earthquake reconnaissance studies in Türkiye showed that buildings with significant overhangs sustained heavier damage compared to regular buildings. In many cases, exterior walls within the overhang portion either partially or completely collapsed, see Diagram 14. These walls were not connected to exterior columns and there were no means of providing attachment to the structure, neither in vertical nor horizontal plane. As a result, these walls were extremely vulnerable to out-of-plane seismic actions. Damaged overhangs were observed at various localities throughout the earthquake-affected area.

Diagram 14. Non-structural damage of exterior partition walls in buildings with overhangs

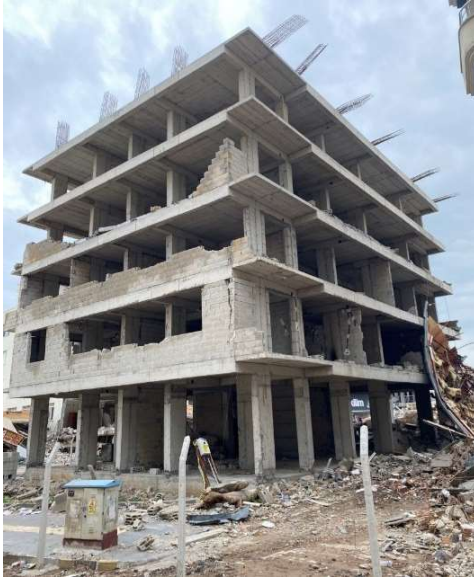
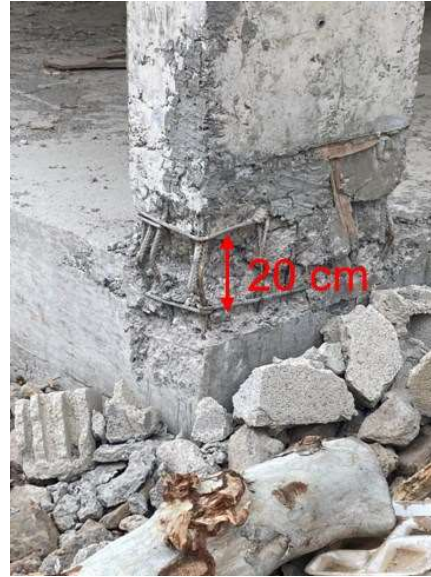
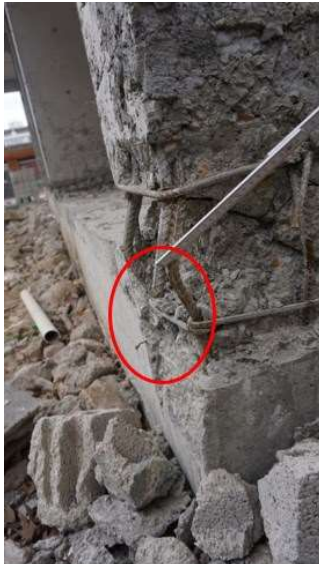
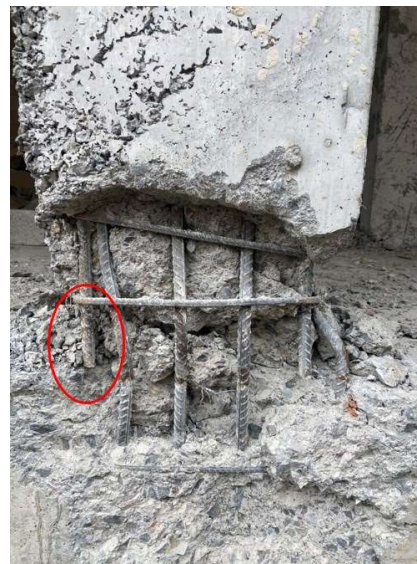
Damage of RC columns in frame systems was also observed in the affected area. The damage was often caused by excessive axial and flexural demand and was observed at the base of the columns which did not have adequate capacity. Damage at the base of the columns could be also attributed to the formation of “strong beam - weak column” mechanism, which is characterized by plastic hinging at the column base and can ultimately lead to a soft storey collapse. This type of damage was observed in a 5-storey building in Nurdagi which was under construction at the time of the earthquakes (Diagram 15). A plastic hinge was formed at the base of a column at the ground floor level. A few detailing deficiencies were also observed in this building; for example, the ties within the critical zone were provided at 20 cm spacing, and 90 degree hooks were used for the anchorage (as opposed to 135 degree hooks which are prescribed for ductile columns). Additional detailing deficiencies included absence of cross-ties which are prescribed by the 2007 seismic design code, at the maximum spacing of 25 times the tie

diameter (corresponding to 20 cm spacing for 8 mm diameter ties). Buckling of longitudinal reinforcement took place as a result of the excessive tie spacing and absence of cross-ties. It was observed that lap splice length for longitudinal reinforcement was very short, and the location coincided with the maximum seismic demand (this observation is common for the columns and structural walls). In some cases it was observed that the ties were not provided in the critical column zones, as observed in a 4-storey residential building in Antakya (Diagram 16).

Diagram 15. Structural damage of an RC building under construction in Nurdağı: a) an exterior view; b) and c) inadequate reinforcement detailing within a critical zone of RC column, and d)

inadequate anchorage of longitudinal reinforcement, and inadequate concrete construction practice (segregation) in RC column

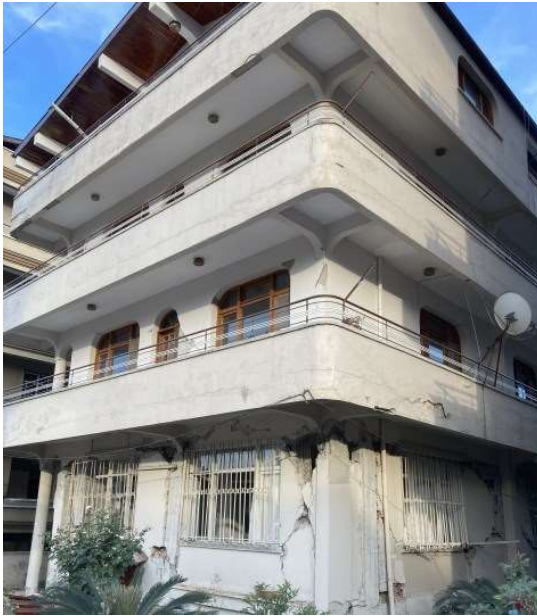
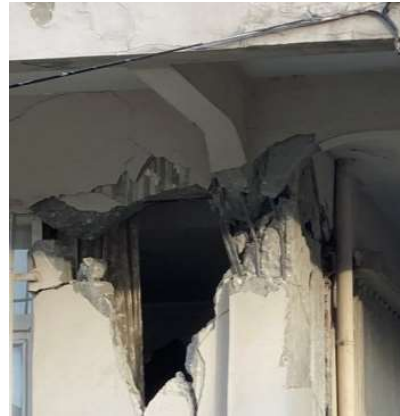
Diagram 16. Damage of an RC column without ties in the critical zone at the top of the first floor level, a low-rise residential building in Antakya (Hatay)
