# Analysis of cracking on running surface of rails

Professional paper

The problem of cracking at the rolling surface of rails is considered in the paper. This damage to the rolling surface of rails, known as "squat", may lead to disintegration of rail head in the length of 1 m or more. In the scope of this research, a detailed visual control of rail damage at the Vrbnica – Bar Section of the Montenegrin railway network was conducted in order to alleviate danger of rolling contact fatigue cracking in rails. Results obtained can be used as basis for preparation of technical regulations for railway track maintenance along the Montenegrin railway network.

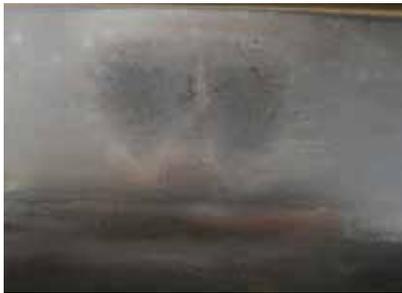
Figure 1. Typical defect in form of "lungs", Vrbnica – Bar Railway, Podgorica – Golubovci Section

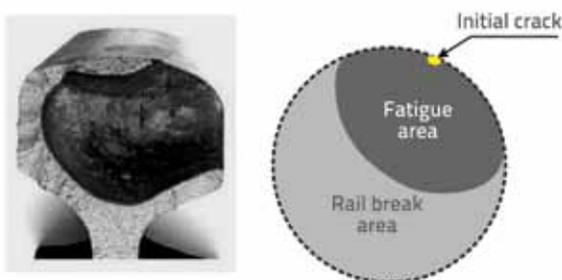
the rolling contact fatigue is quite characteristic. Two visually different surfaces can be distinguished: fatigue area and rail break area (Figure 2).

Figure 2. Typical shape of a steel surface after break caused by squat [6]

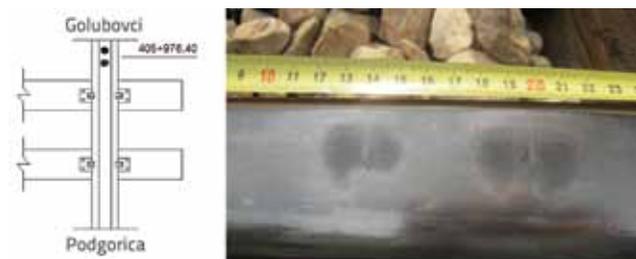
Squats on rails have been located randomly, and they occur in great numbers (Figure 8), which is quite dangerous because of the risk of multiple fractures with significant gaps.

Figure 8. Multiple squat defect (typically shaped as "lungs")

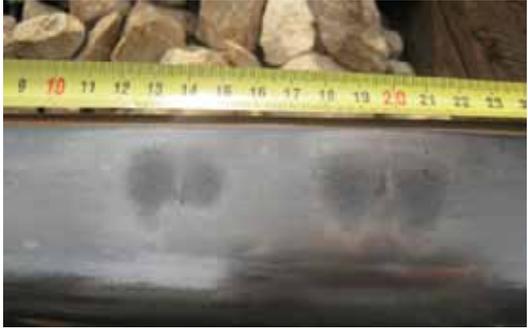
Table 2. Attachment on main form: km 405+804.00

<p>L = 18 mm D = 2 mm</p>	<p>Notes:                  Speed: 90 km/h; Axle load: 22,5 t; Rail profile: S49 (49E1); Quality of steel: R 260;                  Year of manufacture: 1980; Track: main; Rail: left; Straight line</p>
