**DVANAESTO MEĐUNARODNO NAUČNO – STRUČNO
SAVETOVANJE
OCENA STANJA, ODRŽAVANJE I SANACIJA GRAĐEVINSKIH
OBJEKATA**

**DAMAGE OF MASONRY BUILDINGS DURING EARTHQUAKES AND
RETROFITTING AND STRENGTHENING EXAMPLES FROM PRACTICE**

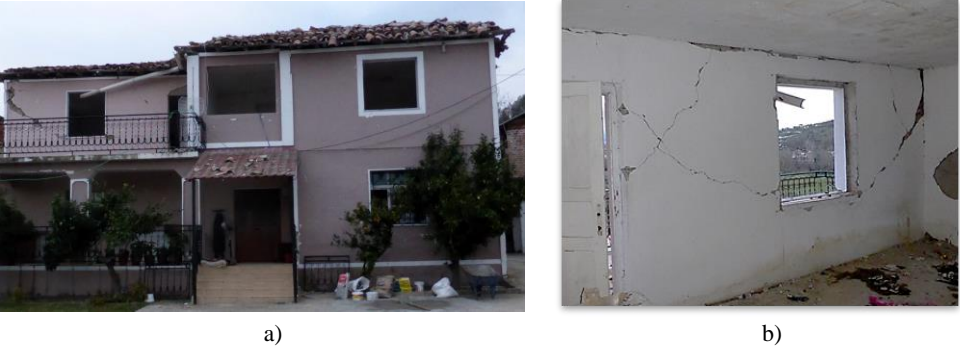
More than 90% of the residential building stock in Albania consists of low-rise single-family masonry buildings (one- or two-storey high) [2]. However, majority of population affected by the November 2019 earthquake (more than 60%) occupied multi-storey residential buildings, because the earthquake affected the country's two largest cities (Tirana and Durrës). Majority of affected buildings consisted of RC frames with masonry infill walls, while masonry buildings were generally not severely affected. Low-rise URM masonry buildings were mostly damaged due to flexible floors or roof structures. Typical damage patterns were diagonal tension cracks caused by in-plane shear demand, such as shown in Fig.1. Majority of masonry buildings constructed before 1990 used solid clay bricks, which were of variable quality. Poor quality of masonry materials (e.g. hollow concrete blocks) and construction were identified as major causes of damage in these buildings [3].

Figure 1. a) Damaged low-rise masonry building made of hollow concrete blocks and b) partial collapse of the demolished building in Thumanë (Albania)

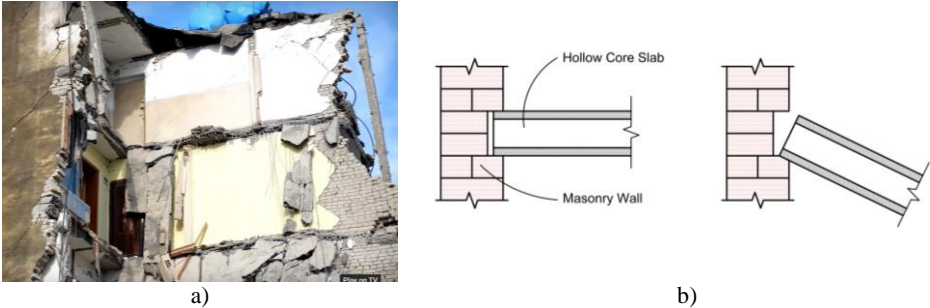
Figure 2. Collapse of mid-rise URM buildings in Thumanë, Albania: a) partial collapse of the building caused by the collapse of the floor slabs and b) detail of a simply supported hollow-core slabs

Majority of multi-storey URM masonry buildings with solid RC floor slabs were not significantly damaged in the earthquake, however some buildings with prefabricated hollow-core RC slabs experienced severe damage. In the town of Thumanë, four 5-storey URM buildings of this type collapsed in the November 26, 2019 earthquake, causing 24 casualties. It is important to mention that these buildings were originally damaged in an earlier earthquake which occurred on September 21, 2019. The major deficiency was insufficient slab support length, which led to the total slab collapse (Fig. 2) [4,5,6].

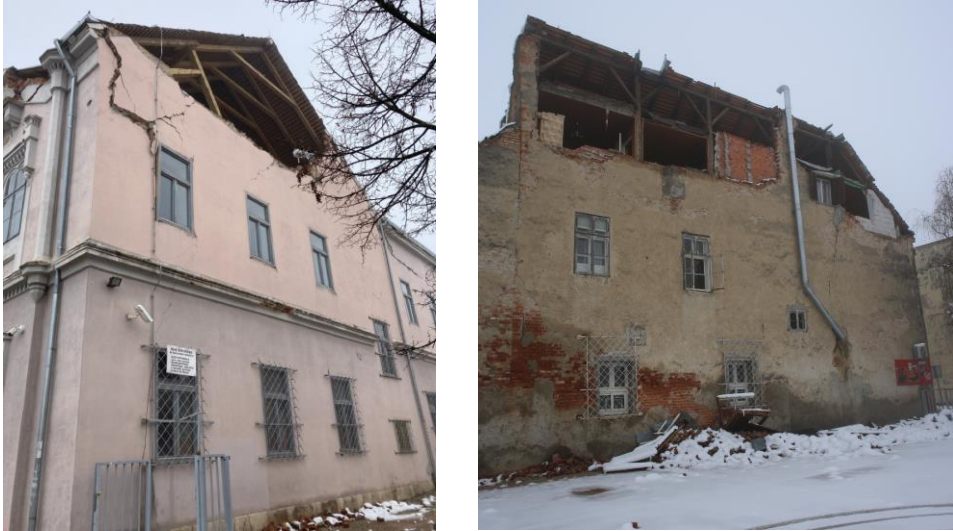
Low-rise masonry residential buildings (either single- or multi-family buildings) were the most common form of housing construction in the area affected by the December 29, 2020 Petrinja earthquake, and many buildings of that type experienced damage or collapse [7]. Older two-storey URM buildings with wooden floors experienced damage or failure of walls due to out-of-plane (OOP) seismic effects (Fig. 3). Excessive horizontal displacements of flexible floor diaphragms caused the walls to act as vertical cantilevers and experience damage or collapse (toppling). The main prerequisite for an efficient seismic behaviour of URM buildings is adequate connection between the masonry walls and between the walls and the floors. Masonry buildings ought to act like a box made up of vertical and horizontal structural elements (walls and floors/roofs). For a good box-like behaviour, the floors should act like rigid diaphragms, and internal seismic forces should be distributed between parallel walls in proportion to their stiffness. This configuration allows to limit lateral displacements (drift) in a masonry structure during an earthquake and prevent extensive damage and collapses. Unfortunately, older masonry structures rarely act as box-like structures, due to inadequate wall-to-floor and wall-to-roof connections, and also due to flexible timber diaphragms; these deficiencies were confirmed by field observations made by the SUZI-SAE team after the 2020 Petrinja earthquake.

Figure 3. OOP Collapse of URM walls in buildings in Petrinja, Croatia

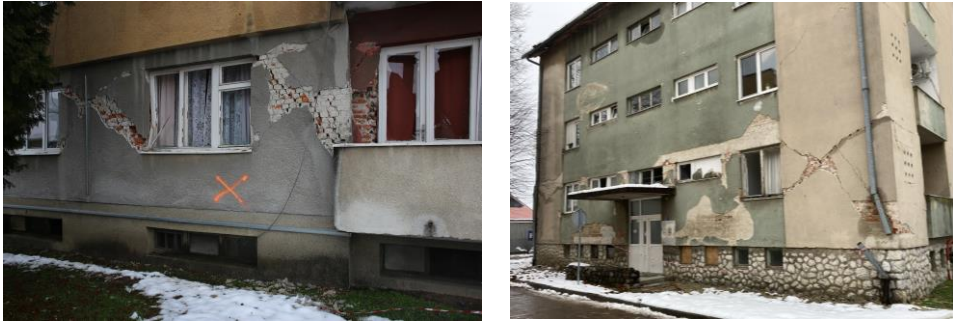
Numerous low- to mid-rise masonry apartment buildings in the epicentral area were affected. Several multi-storey apartment buildings in Petrinja experienced heavy damage. Fig. 4 shows a building which experienced shear cracking in the walls at the

ground floor level. The cracking can be attributed to high in-plane seismic demand and excessively high tensile stresses.

Figure 4. Shear cracking at ground floor level of multi-storey URM apartment buildings in the 2020 Petrinja earthquake
