**MRS-8**

## PALACE OF GOLUBAC FORTRESS

Boško STEVANOVIĆ<sup>1</sup>, Ivan GLIŠOVIĆ<sup>1</sup>, Dragoljub TODOROVIĆ<sup>2</sup>

The paper depicts the reconstruction of the entire Palace, including its foundations and a new roof structure made of glued laminated timber.

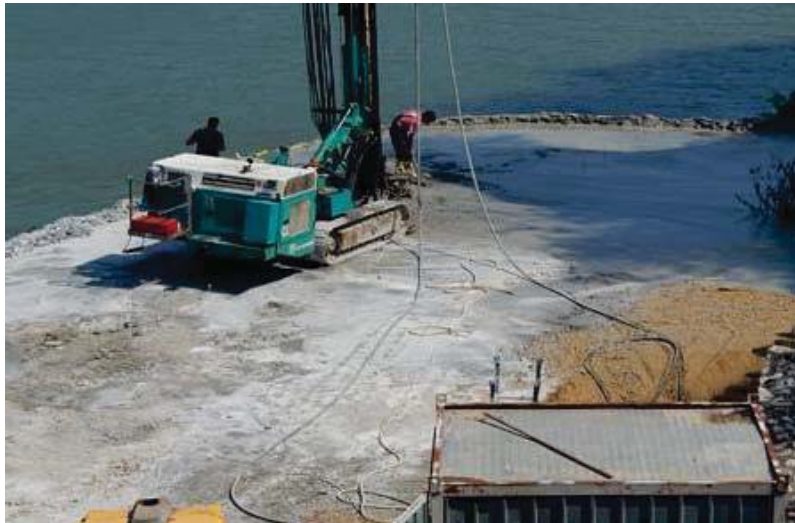
**Fig. 6.** Execution of jet grouting columns

Upon reaching the designed drilling depth, cement grout is injected through the drilling tool, which is simultaneously rotated and raised. The process is pre-programmed and executed automatically. The injection pressure is around 400 bars. Upon withdrawing the drilling rod and bit, a cylindrical body - the column - is formed, which can have varying diameters. There are three basic methods of jet injection: single-fluid, two-fluid, and three-fluid. Since the soil of the Palace, where injection was

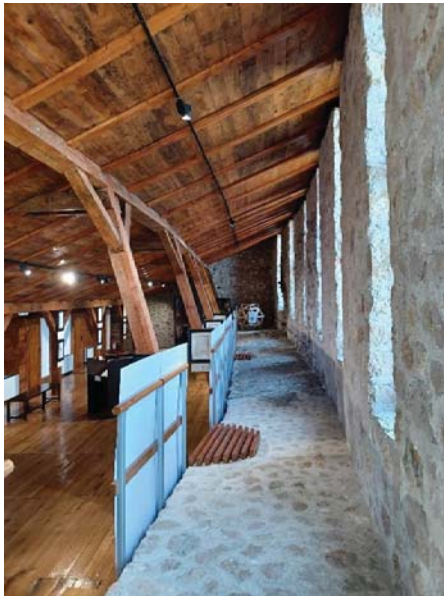
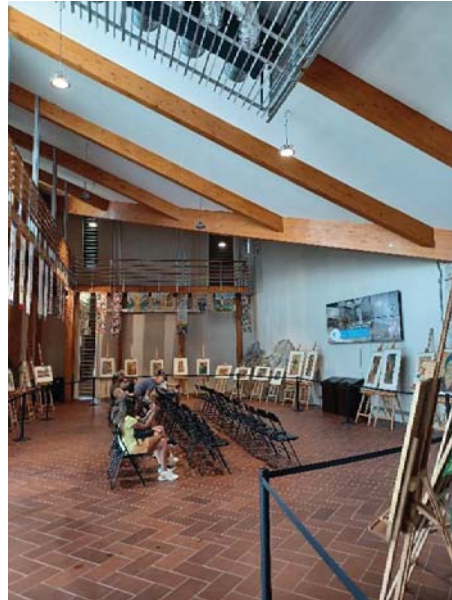
**Fig. 11.** Current interior of the Palace. Left, traditional timber structure; right, modern glued laminated timber structure

In the part where remains of old walls exist (between axes 1 and 6, Fig. 2), a new roof and floor structure of solid (monolithic) timber has been designed. The roof structure is traditional cut roof. The rafters, spaced 80 cm apart, rest on longitudinal stone walls via purlins, and in the central section, they are supported by purlins and ridge beams.

The timber structure in this section consists of ceiling joists, spaced 80 cm apart, over which a plank flooring made of 4.8 cm thick planks is placed. The ceiling joists are supported on their ends by massive stone walls and in the middle by a longitudinal timber beam. This beam is supported on columns via foot plates.

In the Palace section between axes 6 and 14, Fig. 2, a modern glued laminated timber structure has been designed, with timber frames spaced 2.85 m apart. Over the frames, purlins are placed at 80 cm intervals. The girder of the frame is supported on one side by reinforced concrete curtain walls (RC walls) and on the other side by a glued laminated timber column. The columns are connected at the top and approximately at mid-height by horizontal beams. The lower horizontal beam also serves as the support for the gallery, which is suspended from the main roof girder. The gallery floor is composed of 4.8 cm thick planks.
