2018 IPL SYMPOSIUM ON LANDSLIDES

IPL Project 181 – Study of slow moving landslide Umka near Belgrade, Serbia – progress report for 2017 & 2018

Abstract This paper presents a brief working progress report on realization of the IPL project 181 “Study of slow moving landslide Umka near Belgrade, Serbia”. In this paper we will present results of the project targets performed by Project participants during 2017 and 2018, with plans for future project realization.

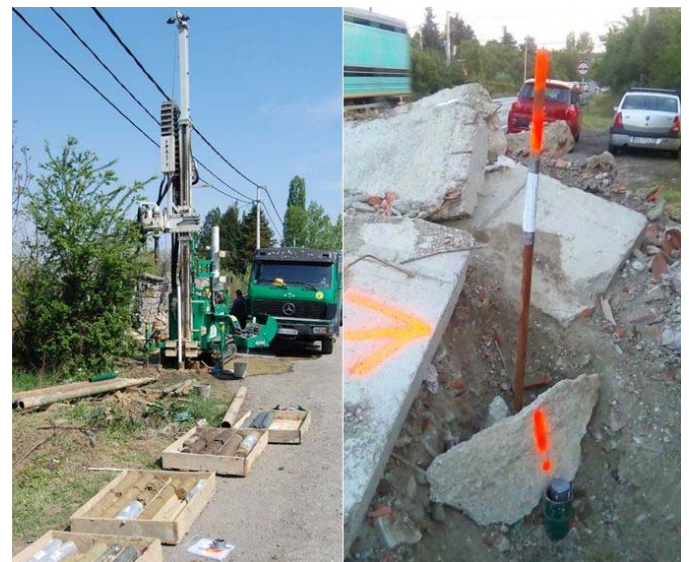
Figure 2 Borehole logging on the Umka landslide (left), destroyed inclinometer construction after 4 months from installation (right).

One borehole was drilled in cooperation with the Highway Institute from Belgrade within the B block of the Umka landslide in April 2017. Borehole was 21 m deep, with coring and standard geotechnical logging and sampling of the core for laboratory tests and

mineralogical analysis (Figure 2, left). Inclinometer construction was subsequently installed in the borehole to the depth of 19 m. Reading was performed continuously every second week until mid of the June, when inclinometer cap was destroyed, and construction was buried with illegal construction waste dump (Figure 2, right). Borehole logs has shown high correlation with the previous research and established terrain models. Slip surface was detected at the depth of 16.9 m. Eight core samples were taken and packed for ring shear apparatus ICL-1 testing at Faculty of Civil Engineering of University of Rijeka (Croatia). Position of inclinometer is displayed on Figure 5.

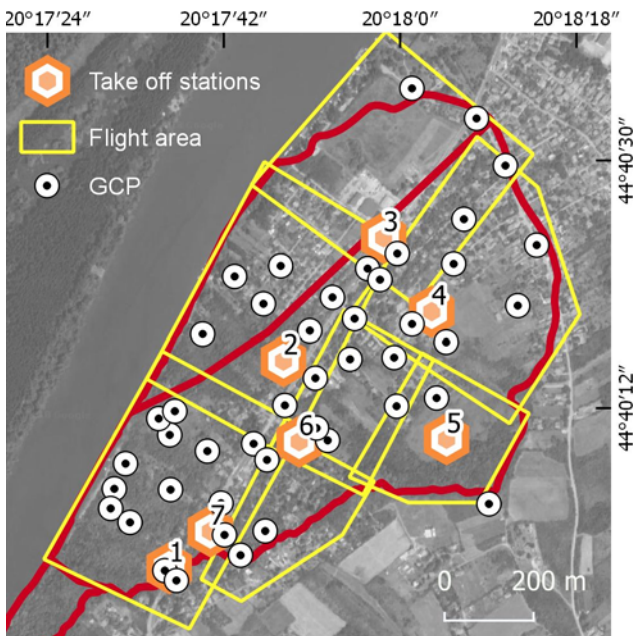
Figure 4 Positions of the drone take-off stations, GCP's and image footprint coverage. Red line outlines the landslide border.

More than 2000 images were taken by UAV during March 2018, but after manually removing blurred and oblique imagery, 1982 images were left for further processing. Forward image overlap was at least 90% and overlap kept between rows of images was around 60%. UAV was flying at height of 80 m above take-off station achieving average pixel size of 2.2 cm. Seven flights were performed in order to cover the area of block A and B (Figure 4). Block C was not imaged for several reasons. Firstly, there are no objects present, and secondly, terrain is heavily vegetated and extremely inaccessible.

Only 45 Ground Control Points were used in bundle adjustment, achieving Root Mean Squared Error of 2.5 cm and optimal measurements coverage. Photos alignment produced 894 923 tie points. Dense cloud was generated by using medium quality option resulting in 188 103 597 points in total. Processing lasted 48 hours by using conventional desktop machine with 16 GB of RAM, 4-core processor at 2GHz each. After ground point filtering, there was 4 896 664 points left classified as ground. Aircraft was DJI MATRICE 600 PRO, industrial hexacopter with mounted DSLR camera Canon EOS 6D with resolution of 20.2 megapixels and focal length of 24 mm.

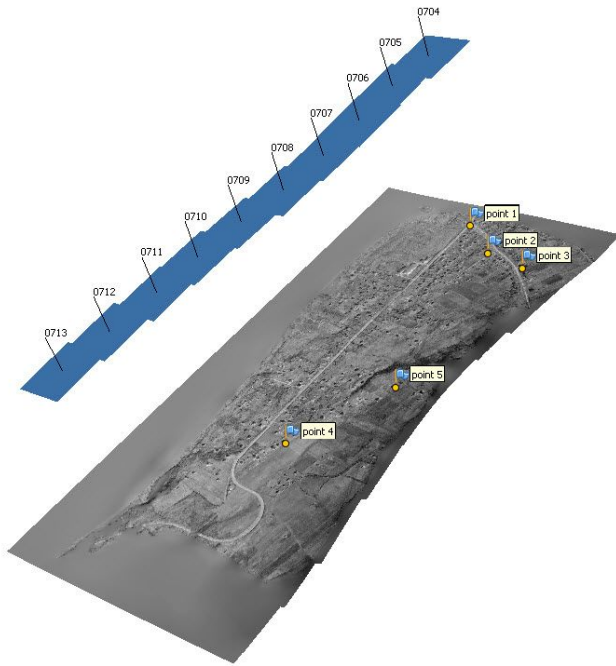
Figure 6 position of historical aerial images, orthophoto created with synthetic GCP's

Historical aerial images of the Umka landslide were obtained from Military Geographic Institute of the Serbian Army for 1959, 1962, 1967, 1970, 1981 & 1988, during 2017 & 2018. The analysis showed that only several images from 1959, 1967 & 1970 could be used for photogrammetric analysis and processing due to optimal scale, tone and brightness of images. For the testing purposes, only images from 1970 were used for processing, while GCP were simulated using DEM that was crated from UAV images. In such circumstances, final model precision was cca. 2 m so further calibration and processing is needed for obtaining desired precision which is less than 1 m. Images were processed by Agisoft software (Figure 6). High resolution DEM and orthophoto images were produced for 1970, since the scales of images were around 1:5000, and due the fact that images were correctly scanned with 1600 dpi.
