# Residential building stock in Serbia: classification and vulnerability for seismic risk studies

**Keywords** Residential buildings · Seismic risk assessment · Building classification · Fragility functions

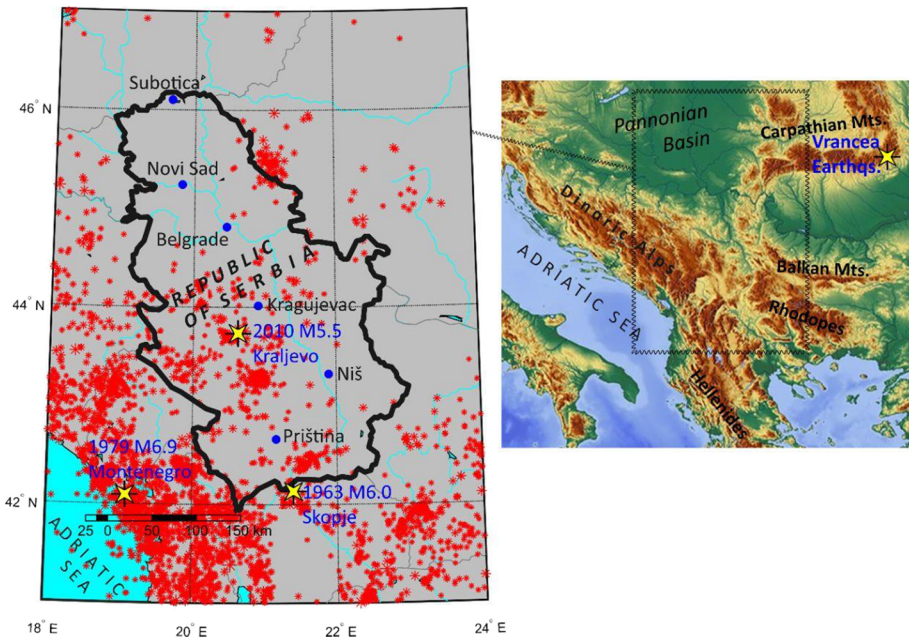
**Fig. 1** Earthquakes in Serbia and the region. **a** Epicenters of the regional earthquakes with  $M_w \geq 3.0$ , recorded between 1900 and 2021 (USGS 2021), including the epicenters of the most significant seismic events from 1963-present, and **b** a geographic map of Serbia (shown within the frame) and the Balkan region, showing the location of the Vrancea, Romania seismic source zone

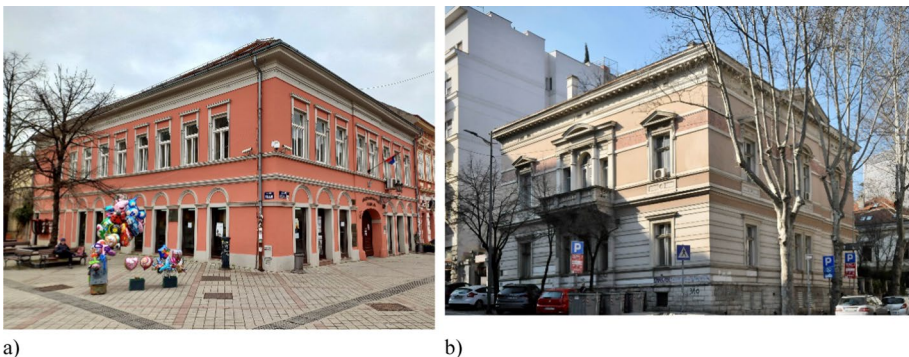
**Fig. 10** URM buildings with flexible diaphragms: **a** type M1: an URM building with adobe walls constructed at the beginning of the nineteenth century in Dunavska Street 2, Novi Sad and **b** Type M2: an URM house with brick masonry walls constructed in Belgrade in 1884

These buildings had wooden floors, consisting of 14 cm×20 cm wooden beams at 80 cm spacing and 2.5 cm thick wooden planks. Flooring consisted of 8 cm thick rammed earth layer supporting a hardwood floor. A vaulted brick floor system, known as jack arch system or Prussian vault (*Pruski svod* in Serbian) was used for the construction of suspended floors above the basement and ground floor levels. The main components of the Prussian vault were shallow brick vaults spanning between the iron beams. Wooden floors were widely used in Serbia until the end of WWI, but were subsequently replaced by ribbed RC floor systems, primarily for building construction in urban areas. The M2-type buildings usually have sloped wooden roofs covered by clay tiles.

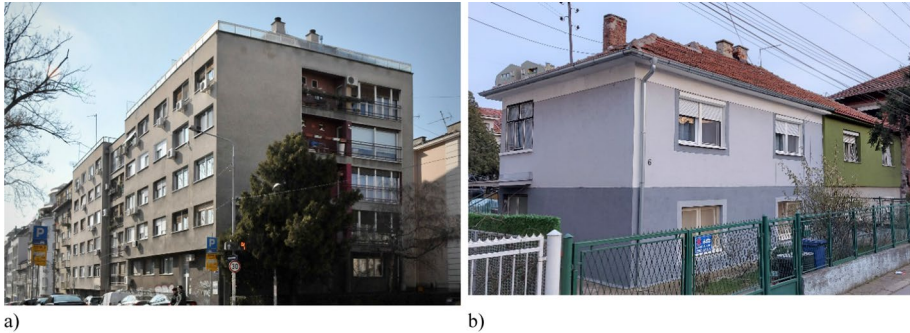
**Fig. 11** URM buildings with rigid diaphragms: **a** type M3-M: a typical 5-storey multi-family residential building in Belgrade (post-WWII construction) and **b** type M3-S: a single-family residential building of the 1960 vintage in Niš

Masonry buildings of type M3-M were constructed from the end of WWI until the beginning of the 1970s. These are multi-family apartment buildings found in Serbian urban centres and usually have 3 to 6 floor levels (Fig. 11a). These buildings are regular in plan and elevation, their wall layout is relatively symmetrical, and there are no elevators (only staircases). Load-bearing masonry walls were typically constructed using solid clay bricks and cement:lime:sand mortar. Typical wall thickness is 38–51 cm and 25–30 cm for exterior and interior walls respectively.

Masonry buildings of type M3-S were constructed from the 1950s until the present time. These are low-rise single-family residential buildings found both in suburban areas of urban centres and rural areas (Fig. 11b). Load-bearing masonry walls were typically constructed using modular (multi-perforated) clay blocks or solid clay bricks and

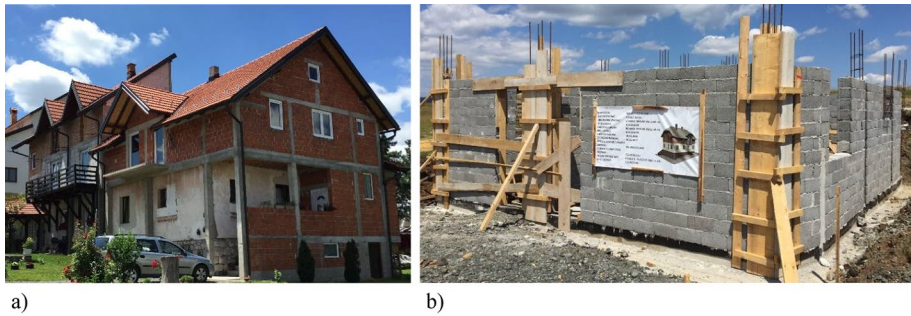
**Fig. 12** Confined masonry buildings – type M4: **a** a 2-storey rural house and **b** a rural house under construction, showing formwork for RC confining elements

The M4 buildings have masonry walls reinforced with horizontal and vertical RC elements. Provision of horizontal and vertical RC confining elements in masonry buildings was required by the first seismic design code of Yugoslavia, which was issued in 1964; however, it is believed that wider application of this technology started in the 1970s. These low-rise buildings (usually 1- to 4-storey high) are used both for single- and multi-family residential construction in urban and rural areas of the country (Fig. 12). These buildings

have masonry walls constructed using modular (multi-perforated) clay blocks, which have been widely used since the 1970s and have replaced solid clay bricks (Đukanović, 2021). Wall thickness ranges from 19 to 25 cm, and a typical mortar composition is a mix of cement, lime, and sand. These buildings have rigid floors, either in the form of cast-in-situ solid RC slabs or semi-prefabricated floor systems (same as M3-type buildings), but the LMT system is also widely used in contemporary construction. These buildings usually have either flat RC roofs (multi-family residential buildings) or sloped wooden roofs (single-family buildings).

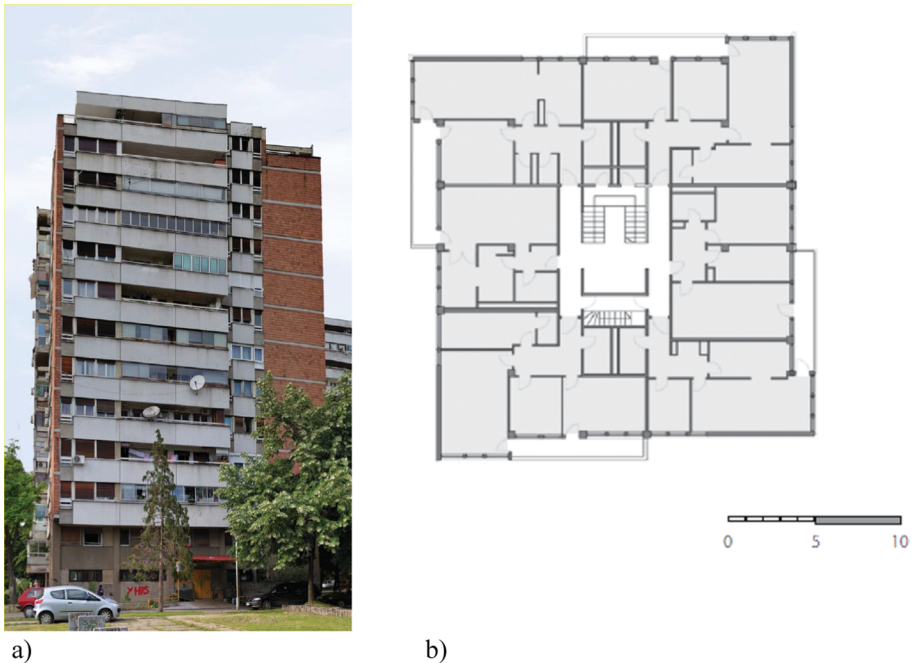
**Fig. 13** Cast-in-situ RC frame building typology—type RC1: **a** a 13-storey multi-family residential building in New Belgrade (Block 45) constructed circa 1970 and **b** a typical floor plan (Jovanović Popović and Ignjatović 2011)

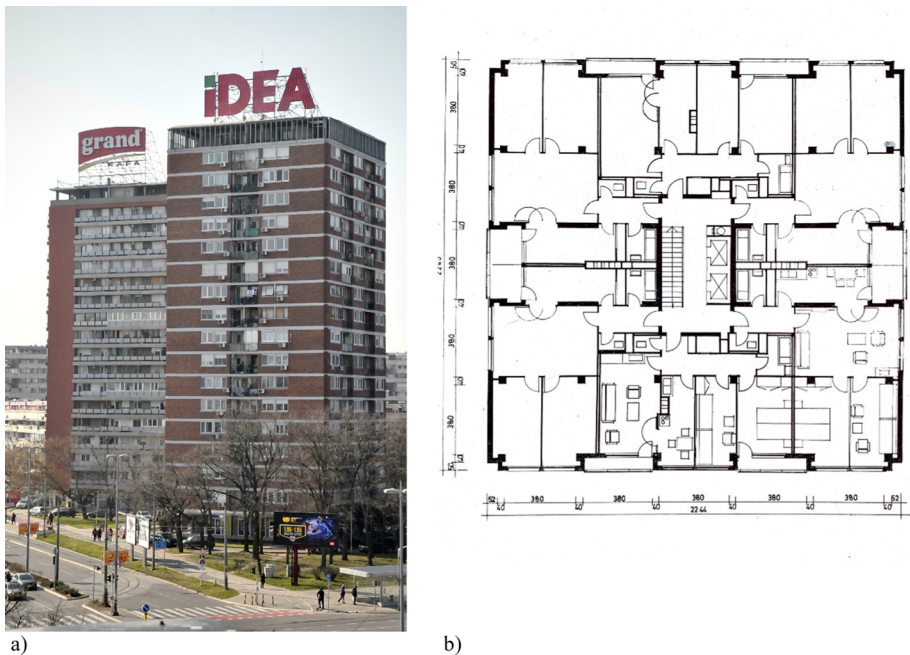
**Fig. 15** Prefabricated RC building typologies—type RC3: **a** a 17-storey multi-family residential building in New Belgrade (Block 21), a part of the complex “The six corporals” constructed in the early 1960s using the IMS technology, and **b** a typical floor plan, showing column grid and RC structural walls (Zanko 1965)

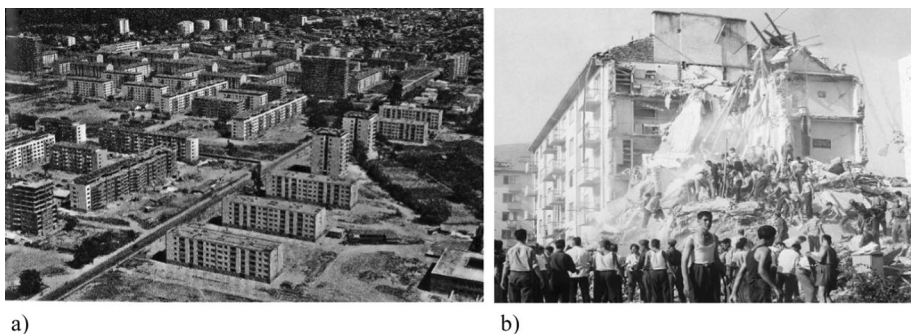
**Fig. 17** Damage of masonry buildings (type M3) in the 1963 Skopje earthquake: **a** Karpoš building complex with 40 3–5 storey URM apartment buildings, and **b** a partially collapsed building No.13. (Source: Milutinovic 2022)

Performance of type M3 buildings in the earthquake can be illustrated on the example of the Karpoš residential complex in the western part of Skopje, which was constructed in the 1950s (Berg 1964), Fig. 17a. The complex comprised of 40 buildings, with the height ranging from 3 to 5 floors. The buildings were designed according to standardized designs, with load-bearing walls provided only in one direction (either longitudinal or transverse). One of the densely populated 5-storey buildings (labelled No. 13) partially collapsed and caused 159 fatalities (Fig. 17b). Various damage patterns were observed in these buildings, ranging from in-plane shear cracks to horizontal offset at floor levels (Berg 1964). Detailed reports on post-earthquake surveys of these buildings are available (Milutinović 2022).

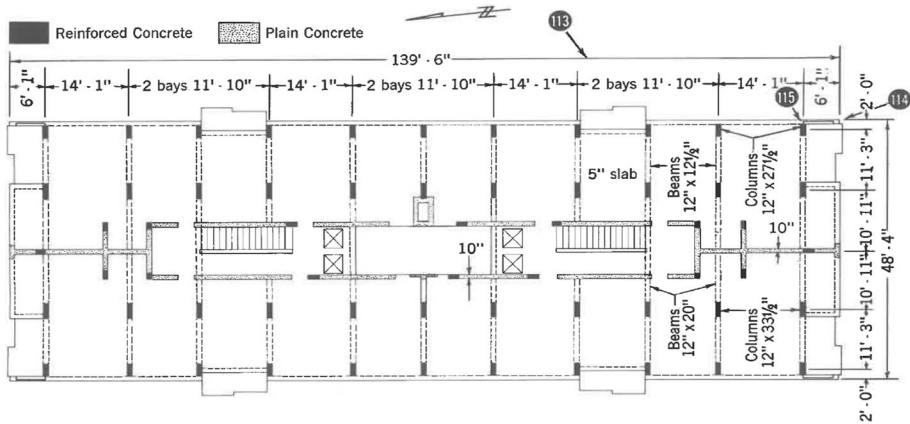
**Fig. 18** Floor plan of Karpoš Tower, Skopje (Berg 1964)

Three 14-storey RC apartment buildings in the Karpoš residential complex (called the Karpoš Towers) were also exposed to the 1963 Skopje earthquake (Berg 1964). The buildings had a cast-in-situ RC frame system with RC floors and can be classified as RC1-type buildings according to the proposed classification. The buildings had a rectangular plan, 43 m long and 15 m wide (Fig. 18). Lateral load-resisting system in the transverse direction consisted of parallel RC frames, at approximately 4.0 m spacing. The frames were discontinued at the stairwells. Plain concrete structural walls were provided in the longitudinal direction along two interior gridlines and around the stairwells. Rectangular RC columns had 70 cm by 35 cm cross-sectional dimensions, 6 longitudinal reinforcing bars

(16–20 mm diameters) and 6 mm ties at 300 mm spacing. Concrete compressive strength of 20 MPa was specified by the original design. Two out of three towers experienced only minor damage, while the third tower experienced severe damage, including cracking in interior walls, horizontal cracking at the floor levels, and severe damage/failure of a corner RC column at the ground floor level (Fig. 19).

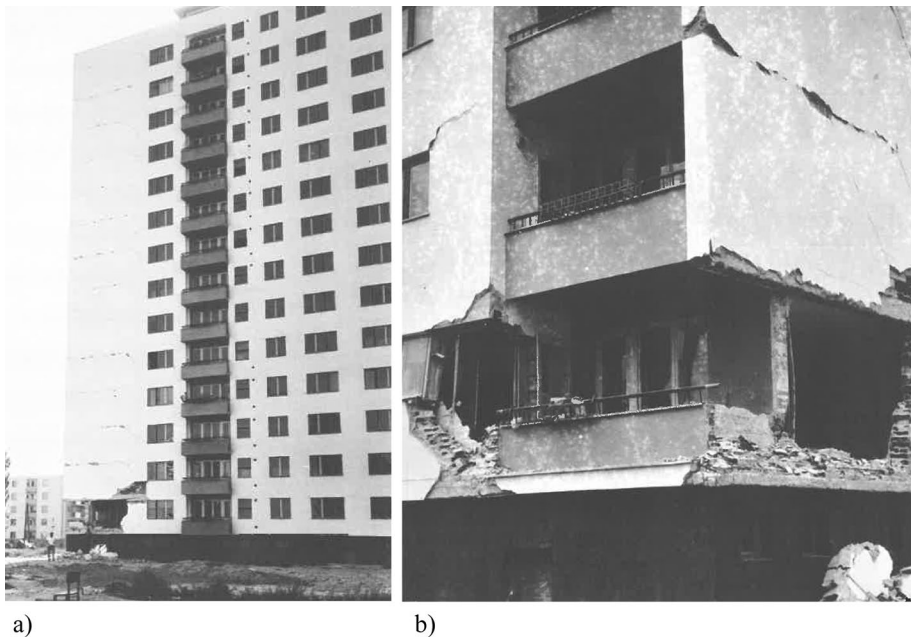
**Fig. 19** Damage of RC buildings (type RC1) in Skopje due to the 1963 earthquake: **a** damaged Karpoš Tower (note the extensive damage at the ground floor level), and **b** a close-up of the damaged region (Berg 1964)

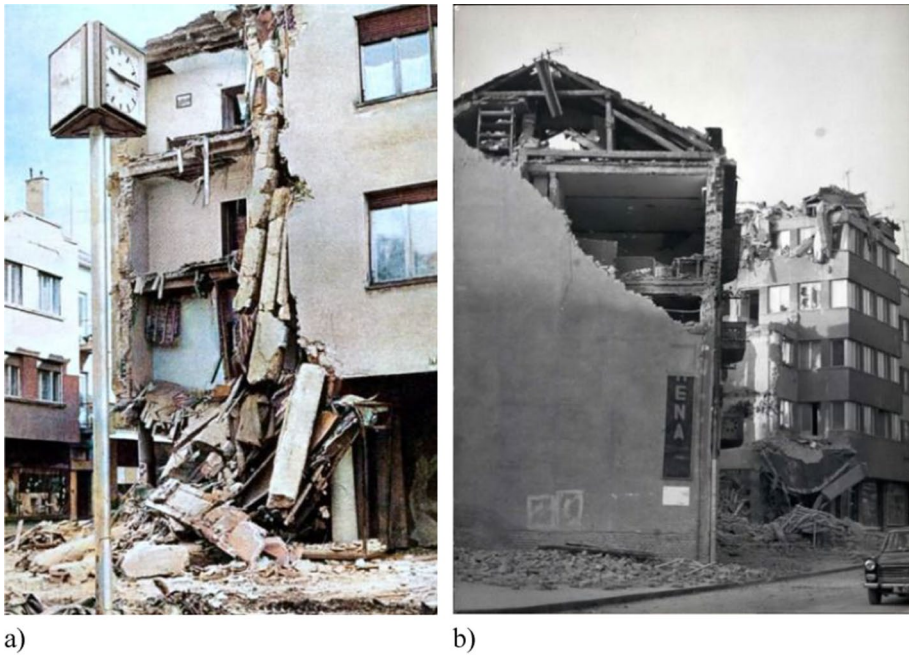
**Fig. 21** Examples of type M2 residential URM buildings in Banja Luka affected by the 1969 earthquakes: **a** a partial collapse of the building with wooden floors (Banja Luka 2009) and **b** collapse of a gable wall (Blic 2019)

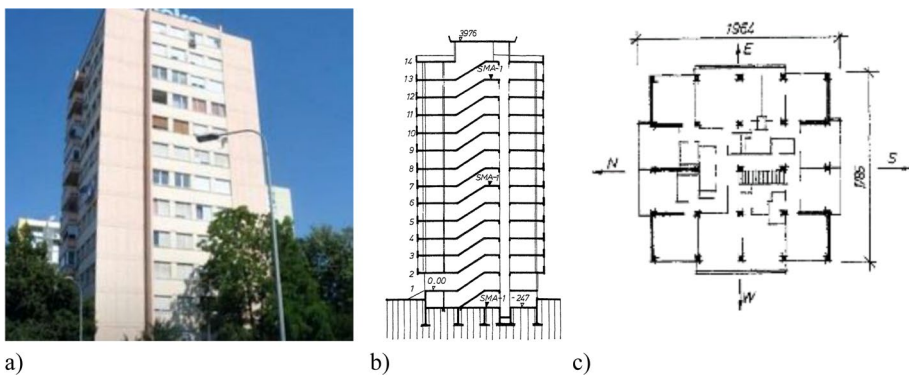
**Fig. 22** An example of type RC3 prefabricated RC building in Banja Luka: **a** exterior view of a 14-storey residential building; **b** elevation, and **c** typical floor plan (Jurukovski et al. 1988)

was not located in an earthquake-prone area according to the official seismic hazard map (UNIDO 1983). Buildings with RC structural walls, including two 14-storey towers which were the tallest buildings in Banja Luka at the time of these earthquakes, experienced either insignificant damage or remained undamaged (Fig. 22). However, a few of the IMS prefabricated RC buildings without structural walls experienced significant non-structural damage of the partition and façade walls and had to be repaired. Some of these buildings

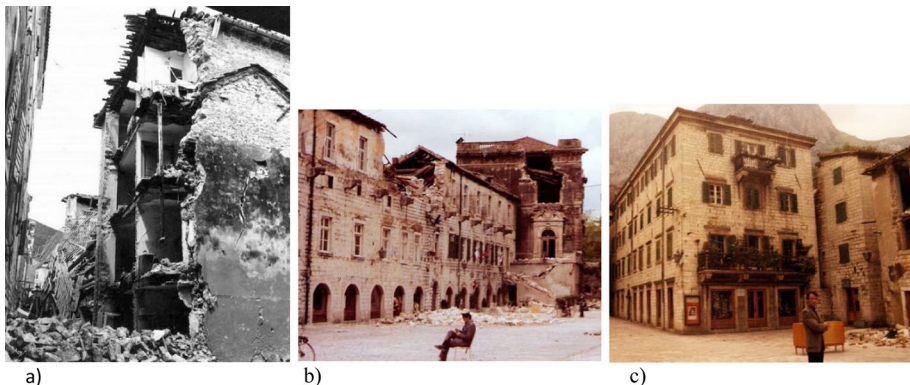
**Fig. 24** Examples of type M1 stone masonry buildings in Montenegro affected by the 1979 earthquake: **a** a street in the historic centre of Budva, showing collapse of stone masonry buildings with wooden floors (RTV Budva 2015); **b** damaged buildings in the historic centre of Kotor (Cafe del Montenegro 2016), and **c** undamaged stone masonry buildings in the centre of Kotor (Petrović 1979)

Older stone masonry buildings with wooden floors and roofs (type M1) were mostly 2- to 4-storey high and were severely affected by the earthquake. Three-wythe stone masonry walls in these buildings had exterior wythes constructed using semi-shaped stone in lime mortar, while interior wythes were filled with rubble. In most cases, these walls were heavily damaged or collapsed due to the lack of connections between the exterior wall wythes, inadequate building integrity, e.g., lack of connections between intersecting walls, and due to inadequate wall-floor connections. Historic centres of Budva (Fig. 24a) and Kotor (Fig. 24b) had the largest stocks of stone masonry buildings, which experienced severe damage or collapse, despite being located at 50–70 km distance from the epicentre. It was observed that some of the well-constructed stone masonry buildings remained undamaged in the earthquake, e.g., buildings in the centre of Kotor, Fig. 24c (Aničić, 1990).

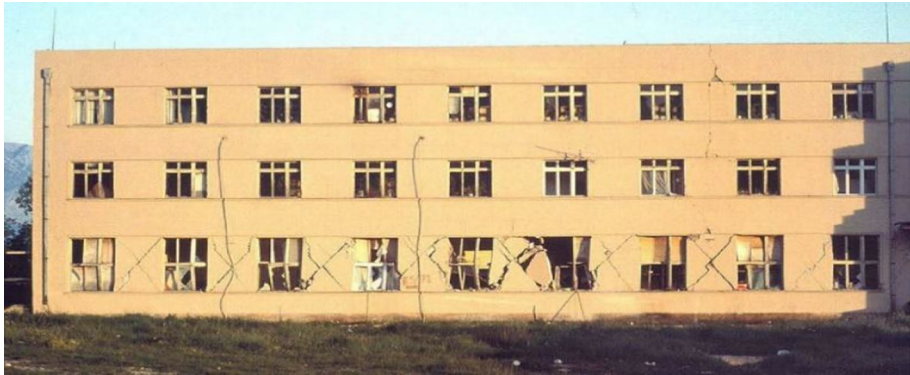
**Fig. 25** Budva Town Hall—an example of a type M3-M building damaged in the 1979 Montenegro earthquake (M. Fischinger)

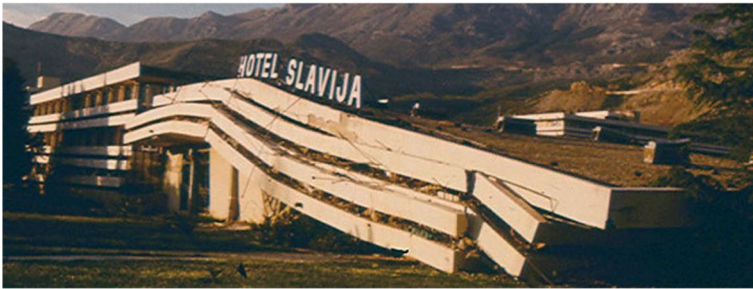
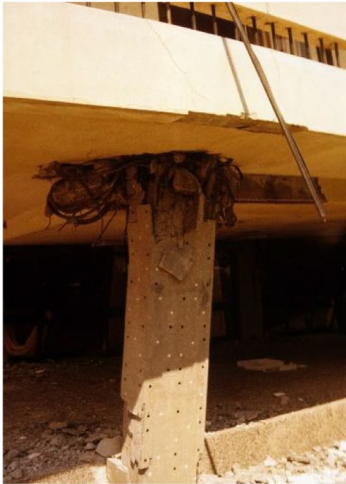
**Fig. 26** Damage of the Hotel “Slavija” buildings (type RC1) in Budva due to the 1979 Montenegro earthquake: **a** an exterior view of the hotel before the earthquake (FOS Media 2020); **b** the collapsed block, and **c** a column damage detail (Petrović 1979)

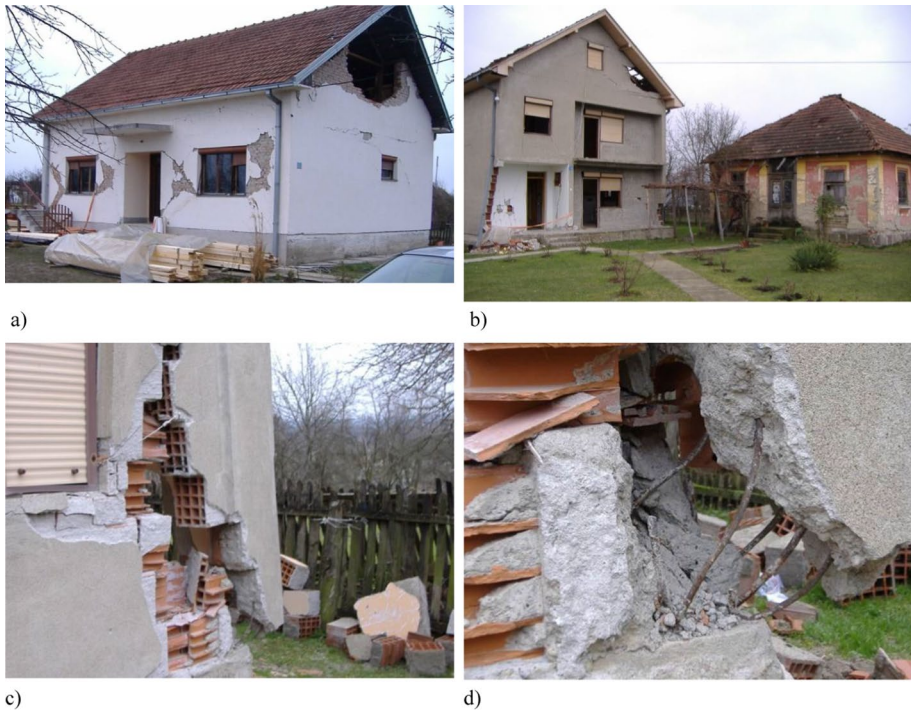
**Fig. 28** Rural single-family masonry buildings affected by the 2010 Kraljevo, Serbia earthquake: **a** a severely damaged type M2 building; **b** a damaged inadequately confined M4 type building (left) adjacent to an undamaged old timber-frame (bondruk) building; **c** and **d** damage at the corners of the building shown in figure **b** due to construction flaws (Manić and Bulajić 2014)

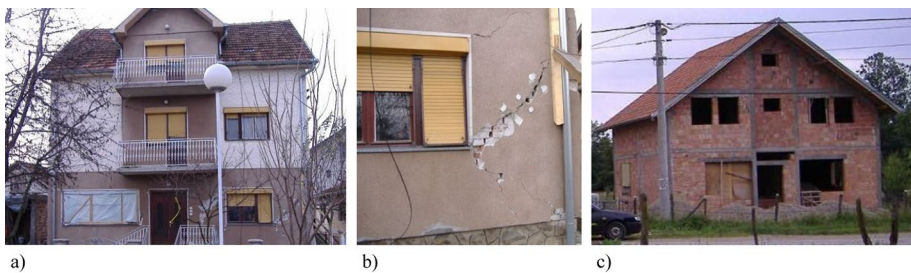
**Fig. 29** Performance of type M4 single-family buildings in the 2010 Kraljevo, Serbia earthquake: **a** a partially confined building (ground floor unconfined and upper floors confined); **b** damage of the same building at the ground floor level, and **c** a fully confined M4 type building under construction that remained undamaged (Manić and Bulajić 2014)

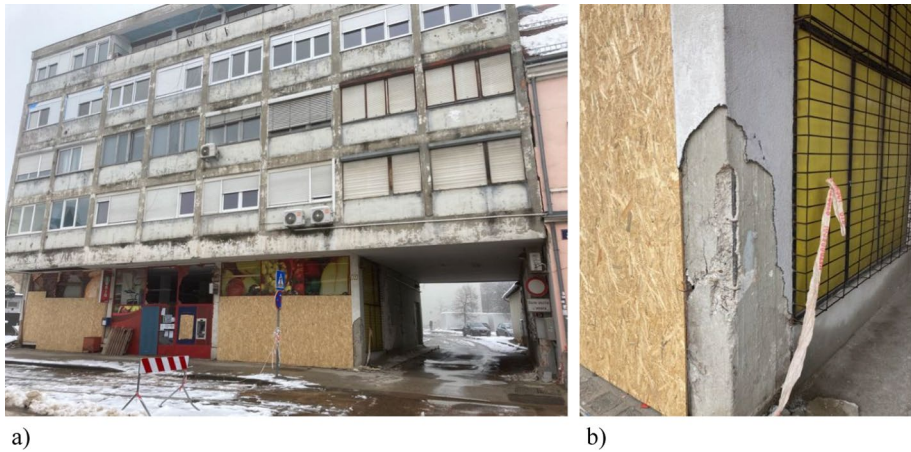
**Fig. 33** Damage of type RC1 residential building in Petrinja, Croatia due to the December 2020 earthquake: **a** exterior view showing open ground floor space which used as a store before the earthquake, and **b** a detail of the damaged RC column (SUZI-SAAE 2021)

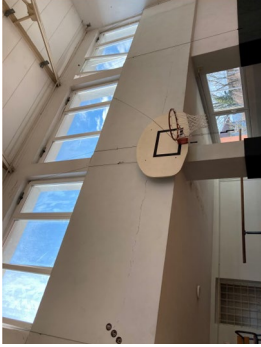
<p>Gymnasium in Primary School “Dragutin Tadijanović”,                      Petrinja (SUZI-SAAE)                      December 29, 2020 Petrinja, Croatia earthquake  <math>M_w = 6.4, I (^{\circ}MCS) = 9</math></p>
<p>Example</p>	<p>Light cracks in plaster in the infill masonry walls</p>

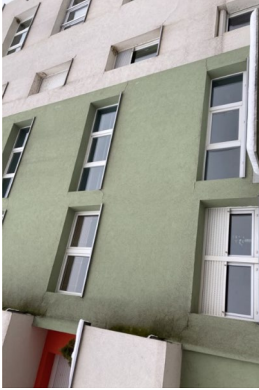
Residential building in Petrinja (SUZI-SAEI) December 29, 2020 Petrinja, Croatia earthquake $M_w = 6.4$ , $I(^{\circ}MCS) = 9$
<i>Damage State 2 (DS2): Moderate damage</i> Slight structural damage, moderate non-structural damage	Hairline cracks in some exterior walls (mostly in the window corners); most of the walls are undamaged  Cracks in many walls Fall of large pieces of plaster Partial collapse of chimneys

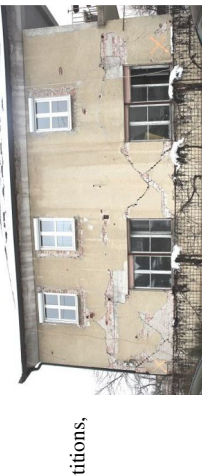
<p>Example</p>	<p>In-plane shear cracks in load-bearing walls; most of the walls were damaged; failure of partition walls</p>	<p>Residential building in Petrinja (SUZI-SAEI)                      December 29, 2020 Petrinja, Croatia earthquake  <math>M_w = 6.4</math>, <math>I (^{\circ}MCS) = 9</math></p>

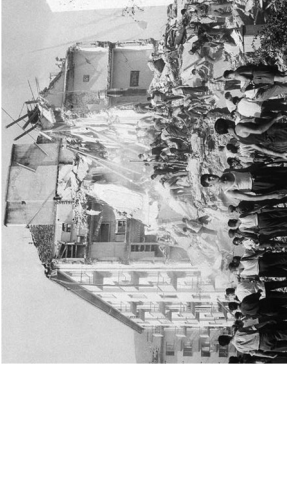
<p>Example</p>	<p>Partial collapse of building No. 13, which had load-bearing masonry walls only in one direction (Berg 1964)</p>	<p>Karpoš residential complex, Skopje (Militinović, 2022) 1963 Skopje earthquake <math>M_w = 6.0</math>, <math>I (^{\circ}MCS) = 9</math></p>

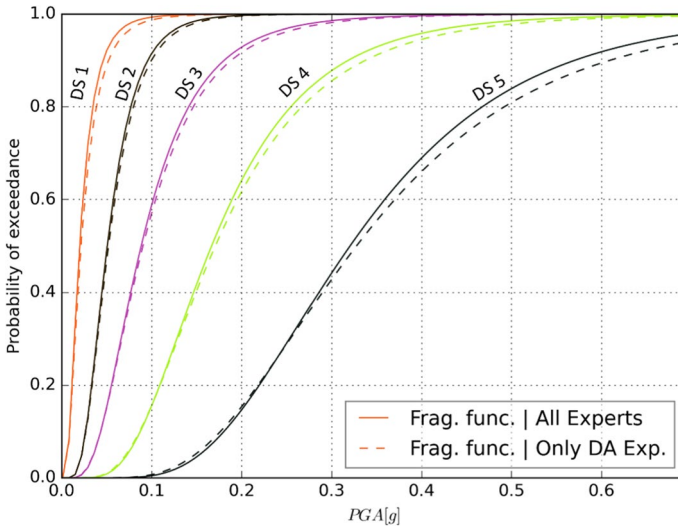
**Fig. 35** Fragility functions for the URM building with rigid floors (type M3-M) derived from expert judgement for different DSs. Solid lines are the DS fragility functions derived based on the opinion of all 40 experts that filled the questionnaire (“All Experts”), while dashed lines are the DS fragility functions derived based only on the opinion of experts with post-earthquake damage assessment experience (“Only DA Exp.”)

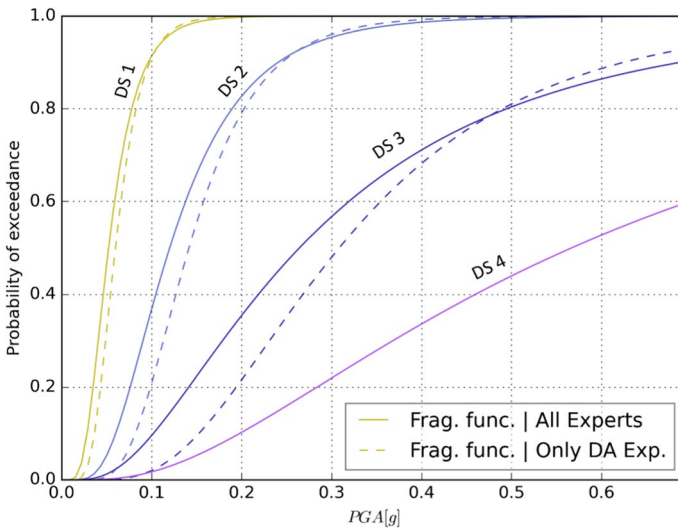
**Fig. 36** Fragility functions for the three-story reinforced concrete frame with infills typology (RC1) from the survey form. The fragility functions are derived from expert judgement for different DSs. Solid lines represent the DS fragility function derived based on the opinion of all 40 experts that filled the questionnaire (“All Experts”), while dashed lines are the DS fragility functions derived based only on the opinion of experts with post-earthquake damage assessment experience (“Only DA Exp.”)
