## SANACIJA OŠTEĆENIH ZIDANIH KONSTRUKCIJA TEHNOLOGIJOM DC 90

### RETROFITTING DAMAGED MASONRY STRUCTURES BY TECHNOLOGY DC 90

Originalni naučni rad / Original scientific paper

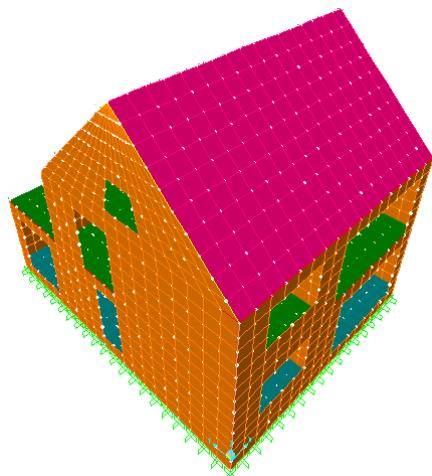
Slika 1. Model konačnih elemenata za dvospratnu zgradu  
Figure 1. Finite element model of two store masonry structure.

Tipična zidana dvospratnica izgrađena od cigle i maltera je pokazana na sl. 1. Modelirana je sa elementima ljsuske. Zemljotres je simuliran sa El Centro zapisom. Analiza je urađena za dejstvo zemljotresa u dva pravca. Proračun pokazuje da se najveći naponi zatezanja, koji su odgovorni za pojavu prslina, javljaju između otvora (prozori, vrata) i da se prsline razvijaju u pravcu dijagonala (sl.2, sl.3).

Typical two store building made from bricks and mortar is shown in Fig. 1. It is modeled by shell finite elements. The earthquake is represented by El Centro response. The analysis is performed with two directions of earthquake effect. Analysis shows that the largest tensile stresses, responsible for crack initiation, occur between holes (windows, doors) and cracks grow in direction of cross diagonals (Fig. 2, Fig. 3).

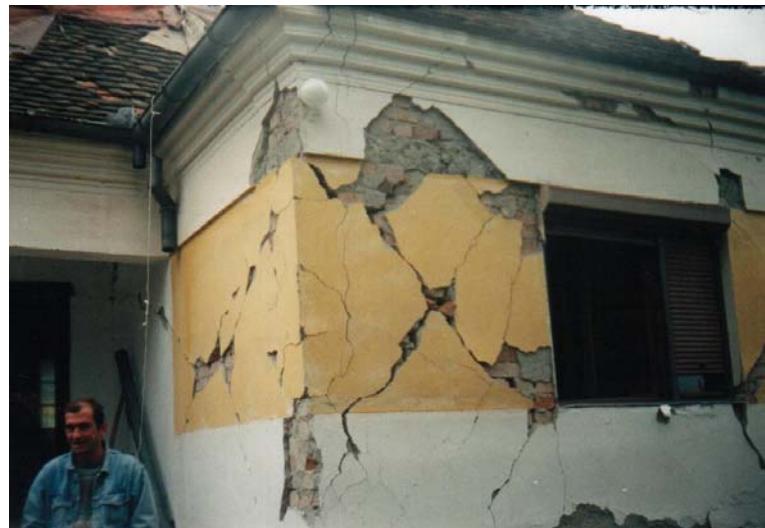
Slika 2. Tipičan oblik i raspored prslina kod zidanih konstrukcija  
Figure 2. Typical crack pattern of masonry structures.

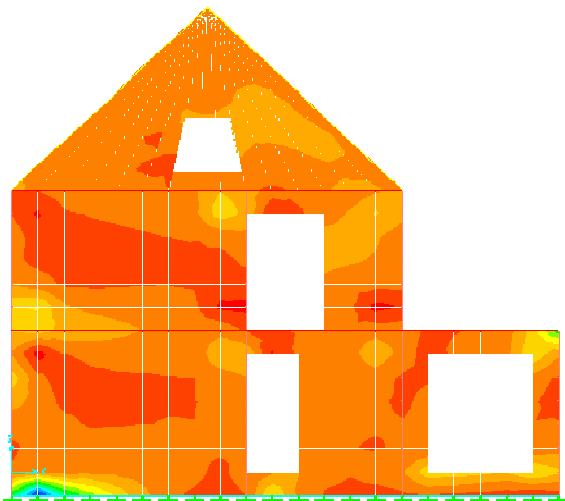
Slika 3. Maksimalni naponi dobijeni konačnim elementima  
Figure 3. Finite element results of maximum stresses.

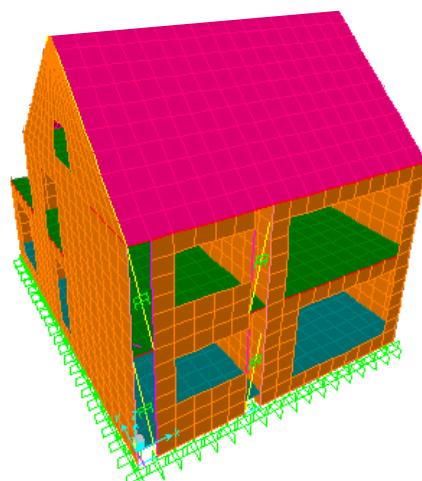
Slika 4. Model konačnih elemenata ojačane konstrukcije  
Figure 4. Finite Elements model of retrofitted structure.

Zidovi se ojačavaju vertikalnim ukrućenjima koja povezuju sve horizontalne ploče i temelj. Vertikalna ukrućenja - rešetke čine vertikalne utege koje se prednaprežu, a ostali elementi rešetke su sami kosnici sa apsorberom seizmičke energije i horizontale kao delovi krutih međuspratnih ploča. Ovako ojačani zidovi postaju duktilni (žilavi) i sposobni da prime alternativna horizontalna dinamička pomeranja.

Walls are strengthened by vertical stiffeners that connect all horizontal slabs and the foundation. Vertical stiffeners – trussess consist of the vertical ties, which are pre-stressed, and the other elements are diagonals with the seismic energy absorber and horizontals as a part of stiff floor slabs. Walls strengthened in this way become ductile (tough) and capable to accept the alternative horizontal dynamic displacements.

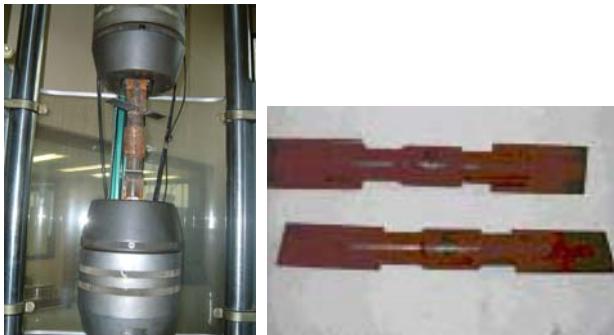
Slika 5. Tipični damperi sistema DC 90 i njihovo testiranje  
Figure 5. Typical dampers of the system DC 90 and their testing

Ispitivanja, obavljena u Vojnotehničkom institutu (VTI), Žarkovo, Beograd (sl. 5.) i (sl. 6.), ukazuju na sledeće:

Testing done in Military Technical Institute (VTI), Žarkovo, Beograd (Fig. 5) and (Fig. 6), show the following:

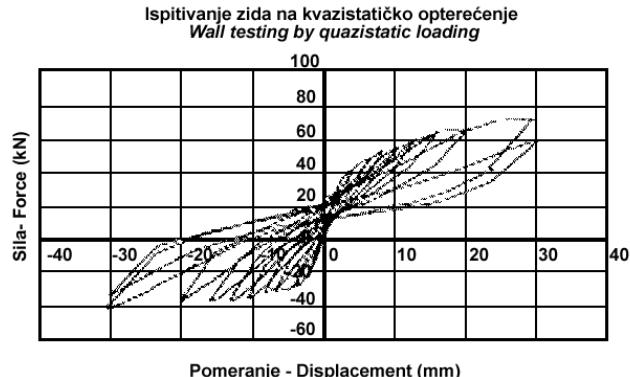
Slika 6. Histerezisni dijagram dobijen testiranjem dampera  
Figure 6. Hysteretic diagram obtained by testing of dampers.

Analizom dobijenih dijagrama zavisnosti sila-pomeranje može se zaključiti da se radi o klasičnom niskocikličnom zamoru. Prilikom rada, u kontroli pomeranja dolazi do pojave trajnih plastičnih deformacija, ili drugim rečima, sa povećanjem broja ciklusa rada dolazi do slabljenja materijala i do smanjenja maksimalne sile (dolazi do pada sile pri istom pomeranju, materijal slab). Što je pomeranje manje, to će broj ciklusa do loma biti veći.

Analysing of diagrams force-displacement, one can conclude that classic low cycle fatigue is in question. During work, in displacement control, permanent plastic deformations appear, or in another words, with increasing number of work cycles material weakens and maximum force drops down (force decreases for the same deflection, material is weaker). With smaller displacement, number of cycles needed for failure is greater.

This is not classical failure of the sample, this is above all weakening of the sample.

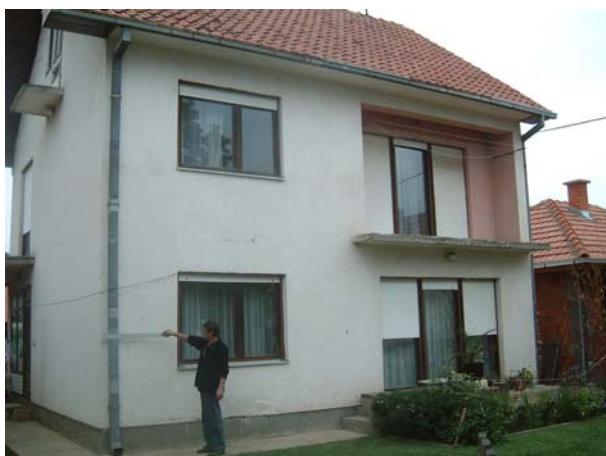
Slika 7. Eksperimentalno ispitivanje objekata  
Figure 7: Experimental testing of objects.

Eksperimentalna ispitivanja na saniranim objektima u Mionici, prikazana na sl. 7. je izveo Institut za zemljotresno inženjerstvo i inženjersku seismologiju (IZIIS) iz Skoplja, metodama ambijentnih i prudnih vibracija pokazala su da dominantne frekvencije izgrađenih objekata nalaze se u opsegu 6-8 Hz, a nakon sanacije se krutost objekata povećava za oko 35%.

Experimental testing on retrofit objects in Mionica, presented in Fig. 7, had been performed by Institute for earthquake engineering and engineering seismology (IZIIS) from Skopje, by methods of ambient and forced vibrations have shown that dominant frequencies of built objects are within the range of 6-8 Hz while after retrofit stiffness raises up to approximately 35%.

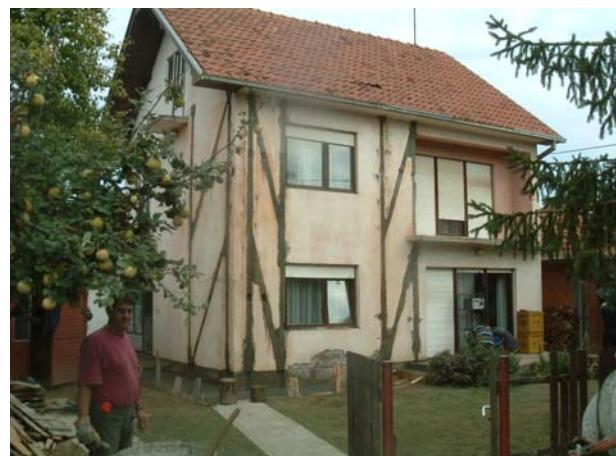
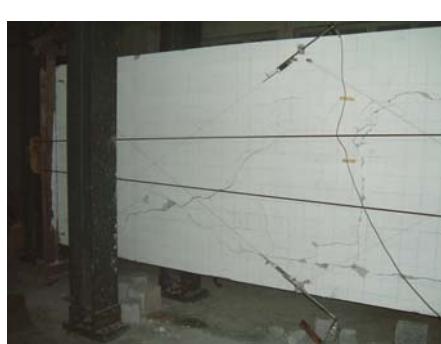
Slika 8. Model dvospratnog zida pre sanacije, posle sanacije i u fazi ispitivanja  
Figure 8. Two-storey wall model, before retrofit, after retrofit and during testing.

Na sl. 8. je prikazan eksperimentalni dvospratni zid izveden na tri načina: (1) od šupljih blokova, (2) u vidu klasičnog rešenja, (3) kao ojačan po sistemu DC 90 i u fazi ispitivanja. Posle nekoliko ciklusa, za pomeranje vrha konzole od 10 mm pojavile su se velike pukotine, 8-10 mm, u pravcu glavnih napona zatezanja u prvom polju do unošenja sile. U polju do uklještenja zida pojavile su se prsline karakteristične za naprezanje sa dominantnim savijanjem.

Početna krutost na smicanje je iznosila  $E_{s-poč} = 60 \text{ kN}/6 \text{ mm} = 10 \text{ kN/mm}$ , da bi posle nekoliko ciklusa za pomeranje od oko 30 mm, pala na  $E_{s-kraj} = 90 \text{ kN}/60 \text{ mm} = 1,5 \text{ kN/mm}$ . Ovaj višestruki pad krutosti zida može se nazvati kolapsom zida i smatrati kolapsom cele zgrade.

Figure 8 presents experimental two store wall made in three forms: (1) from hollow blocks, (2) as classical solution, (3) as strengthened according to DC 90 System and during testing. After few cycles, for deflection of console top point of 10 mm, extended cracks of 8-10 mm appeared in the first area from the point of force application. In the area to the wall constraint, cracks typical for dominant bending stresses appeared.

Initial shear stiffness was  $E_{s-start} = 60 \text{ kN}/6 \text{ mm} = 10 \text{ kN/mm}$ , and after few cycles for deflection of approximately 30 mm, it was decreased to the  $E_{s-end} = 90 \text{ kN}/60 \text{ mm} = 1.5 \text{ kN/mm}$ . This multiple decrease of wall stiffness can be considered as a collapse of the wall and whole building.

Initial shear stiffness was  $E_s = 20/3.5 = 5.7 \text{ kN/mm}$ , and later it slightly decreased, mostly due to anchorage yield of lower tie, and then it rises up again. That leads to the conclusion that anchorage must be done properly, and that quality control of performed works must be done.

Wall behaves much tougher during cyclic loading. For loading of 60 kN, with displacement of the top for 25 mm far less cracks occurred with openings 2–3 mm.

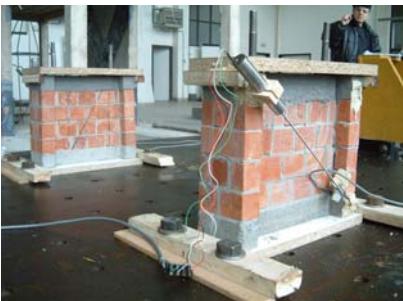
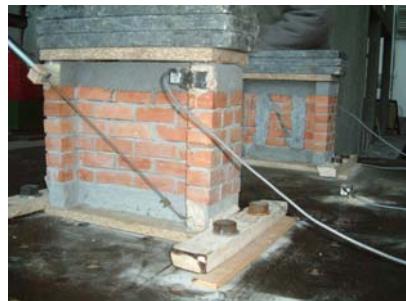
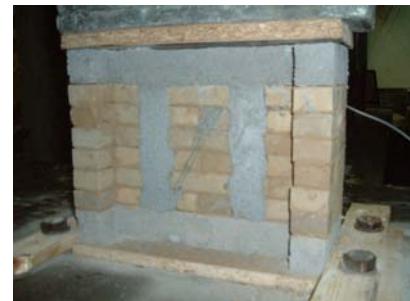
Model 1. Šuplji giter blok - Hollow brick

Model 2 – Pečena cigla - Burned brick.

Model 3 – Sušena cigla - Dried brick

Slika 9. Modelsко испитивање зида на vibroplatformi  
Figure 9. Shaking table test of a wall model.

Modeli su napravljeni u razmeri 1/10, dimenzija: dužina 30 cm, visina 25 cm i debljina 3,5 cm. Prvi tip modela bio je od giter blokova, drugi od obične pečene cigle, a treći od obične sušene cigle (sl. 9). Svaki tip modela je napravljen u dve varijante: kao običan model zidanog zida i kao model ojačanog zida, primenom ojačanja po sistemu DC90. Cilj je bio poređenje ponašanja zidova koji su zidani klasično i onih koji su ojačani po Sistemu DC90, pod dinamičkim opterećenjem, kao i poređenje uticaja tipa cigle na dinamičko ponašanje zida.

Tip modela/ Type of the model	Ojačan model/ Strengthened model	Nejojačan model/ Non - strengthened model
Model 1- giter blok/ hollow block	35.53	24.75
Model 2- pečena cigla/ burned brick	19.95	10.49
Model 3- sušena cigla/ dried brick	6.48	4.40

The models have been constructed in scale 1/10 having the dimensions: length: 30 cm, height: 25 cm and thickness 3.5 cm. The first type of model was made by so-called giter blocks, the second one by plane burned bricks and third model by plane dried bricks (Fig. 9). Each type of model was made in two ways: as conventional and as strengthened by DC 90 System. The idea is to compare dynamic behavior of traditional and strengthening method of construction for the same type of bricks, as well as to compare the influence of brick type to dynamic behavior of the models.
