Marko Marinković¹, Svetlana Brzev², Nemanja Krtinić³, Željko Žugić⁴

SEISMIC PERFORMANCE OF SCHOOL BUILDINGS IN RECENT EARTHQUAKES: LESSONS FOR SERBIA

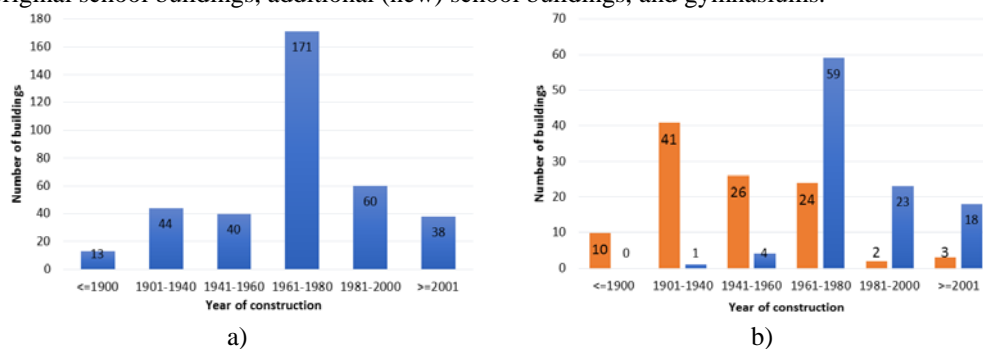
Figure 6 – Year of construction: a) all surveyed school buildings and b) RC (blue) and URM (orange) buildings

One of the most relevant indicators of level of seismic safety is the year of construction, which is shown in Figure 6a. It can be seen that approximately 50% of all school buildings were built in the period 1961-1980, when the 1964 Yugoslav seismic design code was in place.

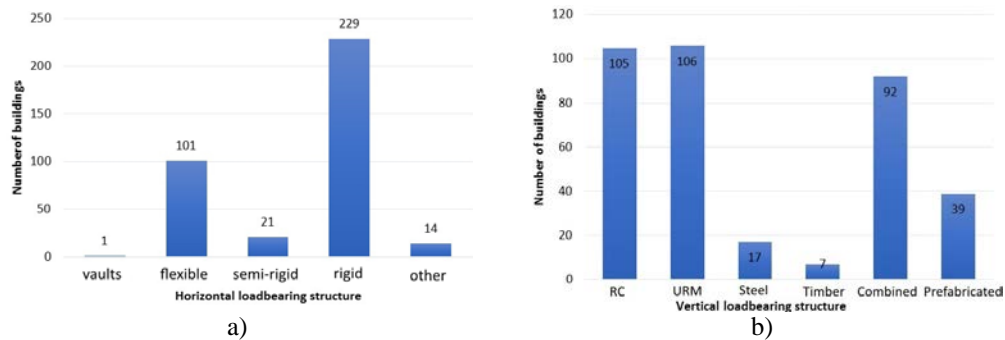
One of the most important criteria is the type of structure, i.e., material of loadbearing (vertical) system, which is the same as the material of Lateral Load Resisting System (LLRS). Vertical system was classified into RC, URM, confined masonry, wood, steel, prefabricated, and combined (e.g. URM and RC, masonry and wood). Horizontal structure has been classified into vaults, flexible floors (e.g. wooden floors), semi-rigid floors (e.g. steel beams), rigid floors (RC slabs), and others. Figure 7 illustrates types of vertical and horizontal structures for the surveyed buildings. It can be observed that most schools (211 out of 366 buildings) have either masonry or RC vertical loadbearing structure. In terms of the horizontal structure, majority of schools (approximately 60%) have rigid floors. Figure 6b shows that most URM school buildings were constructed in the first half of 20th century, whereas majority of RC school buildings were constructed in the second half of the 20th century, mostly from 1961 to 1980.

Figure 7 – Loadbearing structure: a) horizontal and b) vertical
