GEOTECHNICAL ASPECTS OF CIVIL ENGINEERING AND
EARTHQUAKE ENGINEERING - Vrnjačka Banja, 01-03. novembar 2023.

Svetlana Brzev¹ and Marko Marinković²

PERFORMANCE OF REINFORCED CONCRETE BUILDINGS IN THE
FEBRUARY 6, 2023 TÜRKIYE EARTHQUAKES

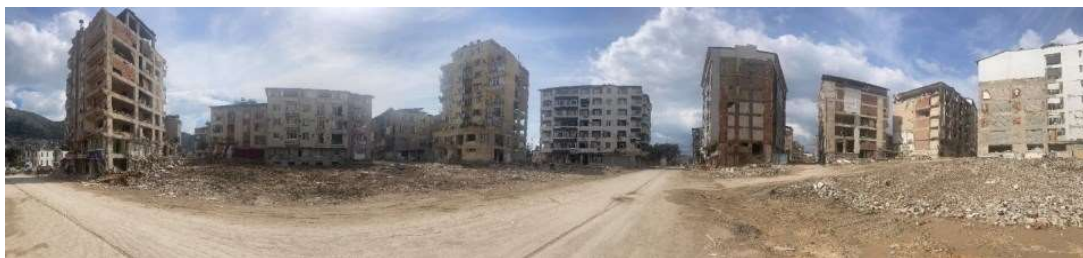
According to the reported building assessment data, more than 230,000 buildings experienced either severe damage or collapse and need to be replaced/reconstructed, while additional 40,000 buildings experienced moderate damage and could be repaired and retrofitted [1]. Many urban centres were devastated by the earthquakes, since majority of buildings collapsed and the remaining buildings had to be vacated and their inhabitants were provided temporary shelter, such as tents or containers. Antakya (also known as Hatay) was one of the most devastated cities, in which majority of inhabitants had to be relocated from their homes (Diagram 4).

Diagram 4. Ruins of Antakya (province Hatay), showing the prevalence of RC buildings (credit: SUZI-SAE).)

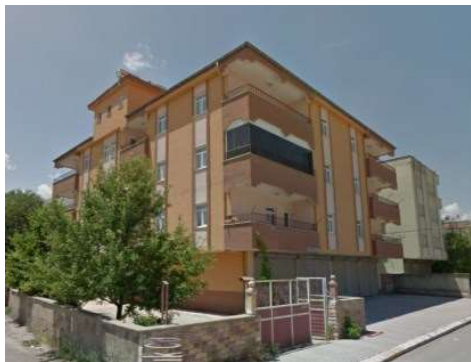
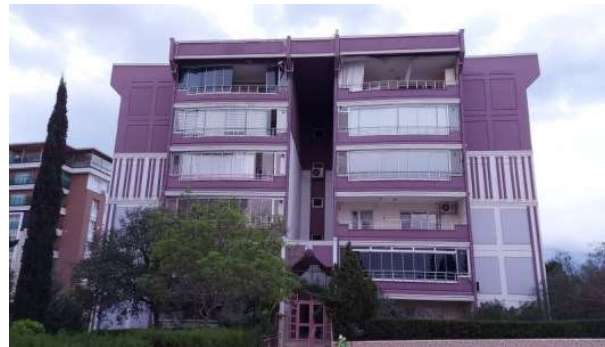
Majority of the affected RC buildings have a beam-column frame system, with or without structural (shear) walls, which are the main focus of this paper. A smaller fraction of RC buildings have a flat slab system, with one-way or two-way ribbed slabs supported by the columns (Diagram 5a). These slabs have „hidden“ beams, that is, shallow RC beams with the depth equal to the slab thickness. The voids in the slabs are often infilled by masonry elements (blocks). Buildings of this type were exposed to the November 26, 2019 earthquake and many of them experienced damage due to excessive flexibility of the lateral load-resisting system [9], [10].

Another RC technology used for building construction in Türkiye is tunnel form technology. These buildings are constructed by casting walls and floors in a fast manner, since the formwork is reusable for different floors. The main lateral load-resisting system consists of structural walls (shear walls). Seismic performance of these buildings has been satisfactory, with some non-structural and structural damage but collapse is rarely reported. These buildings are usually constructed in Türkiye for social housing implemented by TOKI (the Housing Development Administration of the Republic of Türkiye). Refer to [11] for examples of typical projects.

Diagram 5. Typologies of RC buildings in the earthquake-affected area of Türkiye: a) building with a flat slab system, Kirikhan, and b) building with a tunnel form construction, Elbistan (credit Nemanja Krtinić).

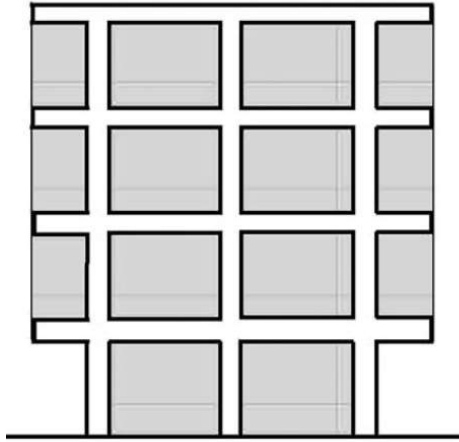
Another cause of non-structural damage in RC buildings was related to overhangs, that is, an increase of the floor area above the ground floor level (see Diagram 13). Overhangs at the upper floors are created when floor slabs project outwards from the exterior column axes. These overhangs cause a difference in stiffness and mass between the ground floor and upper floors (a vertical irregularity). Post-earthquake reconnaissance studies in Türkiye showed that buildings with significant overhangs sustained heavier damage compared to regular buildings. In many cases, exterior walls within the overhang portion either partially or completely collapsed, see Diagram 14. These walls were not connected to exterior columns and there were no means of providing attachment to the structure, neither in vertical nor horizontal plane. As a result, these walls were extremely vulnerable to out-of-plane seismic actions. Damaged overhangs were observed at various localities throughout the earthquake-affected area.

Diagram 13. An elevation of a building with overhangs [13].
