# Analysis of cracking on running surface of rails

Professional paper

The problem of cracking at the rolling surface of rails is considered in the paper. This damage to the rolling surface of rails, known as "squat", may lead to disintegration of rail head in the length of 1 m or more. In the scope of this research, a detailed visual control of rail damage at the Vrbnica – Bar Section of the Montenegrin railway network was conducted in order to alleviate danger of rolling contact fatigue cracking in rails. Results obtained can be used as basis for preparation of technical regulations for railway track maintenance along the Montenegrin railway network.

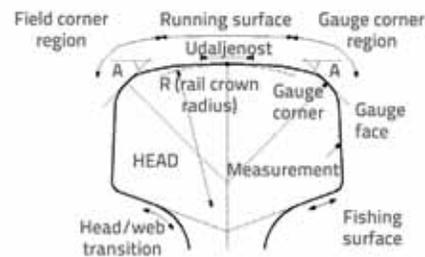
The occurrence of squats is directly caused by excessive dynamic wheel/rail contact force due to vertical irregularities on the running surface of the rail. Squat zones are shown in Figure 4: running surface within the rail crown radius ( $R$ ) and the gauge corner region.

Figure 4. Squat zones in rail head: running surface

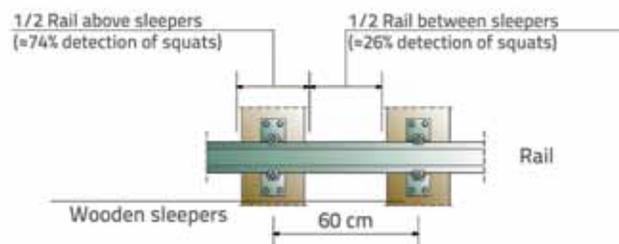
Visual inspection on the Vrbnica – Bar railway section [8] has confirmed the correlation between squat locations and the stiffness and damping characteristics of the track. Approximately 75 % of all squats were registered on the  $\frac{1}{2}$  of the rails centered on sleepers, and the remaining squats were noted on the other  $\frac{1}{2}$  of the rails in the centre between two sleepers (Figure 5).

Figure 5. Squat locations on track

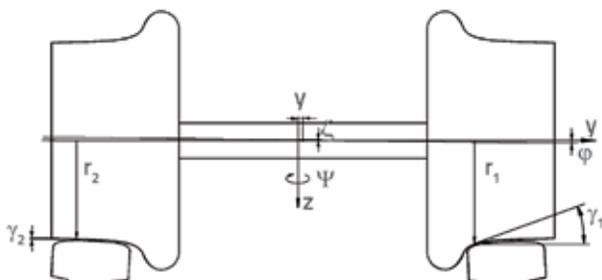
To determine the force acting in the wheel/rail contact zone, the following range of geometrical parameters must be known: position of contact points on the left-side and right-side wheels, position of contact points on the left-side and right-side rails, current radius of circles at contact points ( $r_1, r_2$ ) and their difference ( $\Delta r$ ), equivalent conicity, profile angle at contact points ( $\gamma_1, \gamma_2$ ), radius of wheel profile and rail curvature at contact point, coefficient of contact stress at contact point, angle of axle assembly toward the horizon ( $\phi$ ), and vertical displacement of its centre of gravity ( $\zeta$ ) (Figure 6).

Figure 6. Geometrical parameters for determination of wheel/rail contact forces [15]

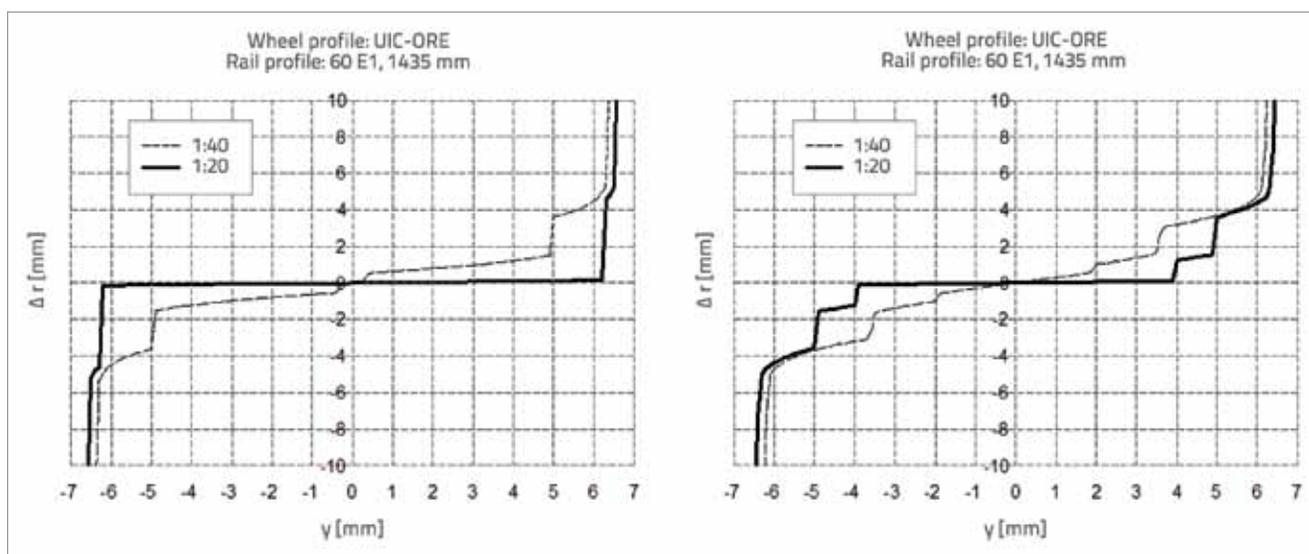
In addition, wheel/rail contact forces depend on: wheel profile and its current geometry, rail profile and its current geometry, rail inclination (1:20, 1:40, 1:∞), current track gauge, and current wheel flange gauge (Figure 7).

Figure 7. The  $\Delta r$  function (difference of current radii at the contact points) [15]

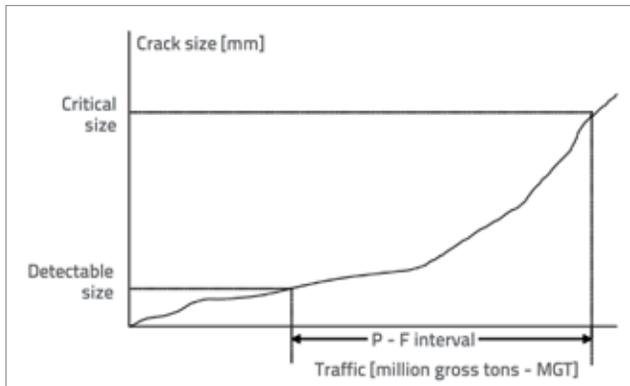
can be expected (F – failure due to breakage). The time or traffic load (expressed in millions of gross tons) between crack detection and rail break can be used to define the P-F interval (Figure 9).

Figure 9. Definition of P-F interval [19]

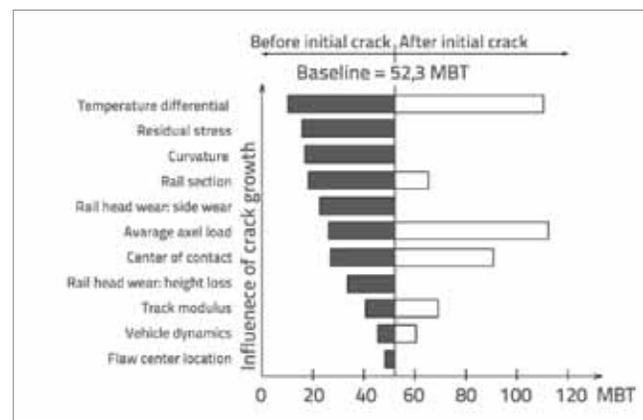
As a part of the project [19], a sensitivity analysis was performed to demonstrate how the crack growth rate is affected by different traffic and track conditions. Figure 3 shows the result of the analysis [19]. Various factors are ranked according to their impact on crack growth over the rail life span.

Figure 10. Influence of various factors on crack growth [19]
