ŠINSKI DEFEKTI USLED ZAMORA MATERIJALA

RAIL DEFECTS DUE TO ROLLING CONTACT FATIGUE

Zdenka POPOVIĆ
Leposava PUZAVAC
Luka LAZAREVIĆ

ORIGINALNI NAUČNI RAD
UDK: 006.77:624.04.001.23:699.841(497.11+1) = 861

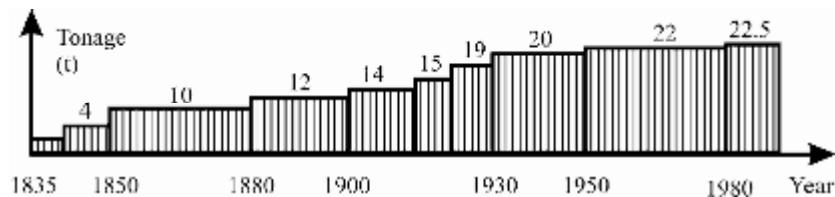
Slika 1. Porast osovinskog opterećenja [8]
Figure 1. Increase of the axle load [8]

Rail defects due to rolling contact fatigue in the areas of high wheel/rail contact stress is a marked phenomenon and a problem on the railways worldwide. At first, defects of this type have been observed only on the tracks of heavy haul lines with high axle load (figure 1). However, nowadays the same occurrence is discerned on conventional lines for mixed traffic as well as on the high speed lines, especially for the speeds over 200 km/h.

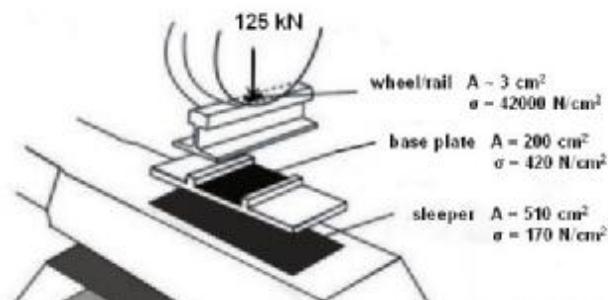
Slika 2. Veliki napon u dodiru točka i šine [7]
Figure 2. High wheel/rail contact stress [7]

Kada se točak teškog teretnog šinskog vozila osloni na šinu, oba tela u tački dodira dobijaju ugib. Formirana dodirna površina točka i šine je izuzetno mala i iznosi svega $1.5 - 3.0 \text{ cm}^2$ (slika 2). Velika opterećenja od točka prenose se preko male dodirne površine na šinu, što stvara velike napone pritiska. Prekoračenjem granice elastičnosti, šinski čelik se istiskuje ka neopterećenoj okolini dodirne površine, remeti se njegova mikrostruktura i dolazi do plastične deformacije šine.

When the wheel of a heavy freight vehicle relies on the rail, both bodies are flexed at the point of contact. Thus formed wheel/rail contact surface is very small and it measures only $1.5 - 3.0 \text{ cm}^2$ (figure 2). High load is transferred over the small wheel/rail contact surface from the wheel to the rail, which creates high pressure stress. Overflow of the elasticity limit forces the rail steel outwards toward unstressed contact surface environment, its microstructure is perturbed and the rail suffers plastic deformation.

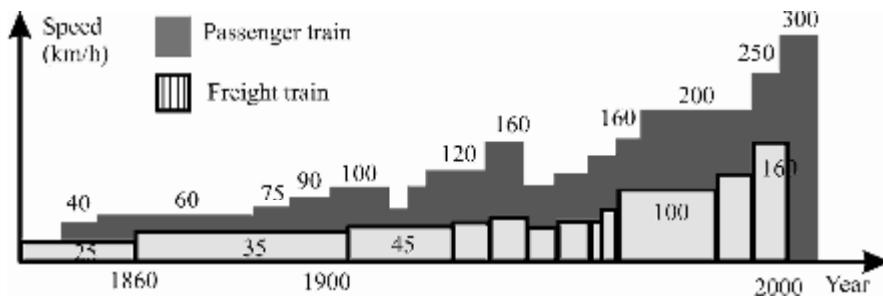
Slika 3. Porast brzina [8]
Figure 3. Increase of the speed [8]

Sa druge strane, sa porastom brzina na prugama ukupno opterećenje (slika 3) od točka koje deluje na šinu povećava se zbog porasta udela dinamičkog opterećenja. S obzirom na to da upravljač železničke infrastrukture nema uticaj na konstrukciju i stanje vozila, jedan od raspoloživih načina da utiče na smanjenje dinamičkog opterećenja koje se prenosi na šinu je upravljanje održavanjem profila glave šine.

On the other hand, the increase of line speed (figure 3) increases total wheel stress on the rail due to an increase of the dynamic stress rate. Since the infrastructure manager doesn't have influence on the construction and condition of the vehicle, one of the available ways to influence reduction of dynamical stress transferred to the rail is managing rail head profile maintenance.

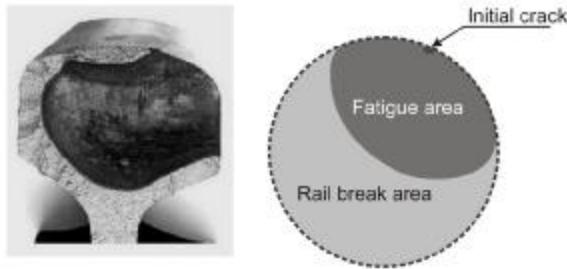
Slika 4. Karakteristični izgled površine materijala nakon loma usled zamora šinskog čelika
Figure 4. Characteristic look of a steel surface after break caused by rolling contact fatigue

Generally, a fracture surface due to rolling contact fatigue has a characteristic figure. Two visually different surfaces can be distinguished: fatigue area and rail break area (figure 4).

Fatigue area has a smooth and dark surface where the lines of fatigue crack increase can be distinguished, and it is on the places of increased stress concentration, due to:

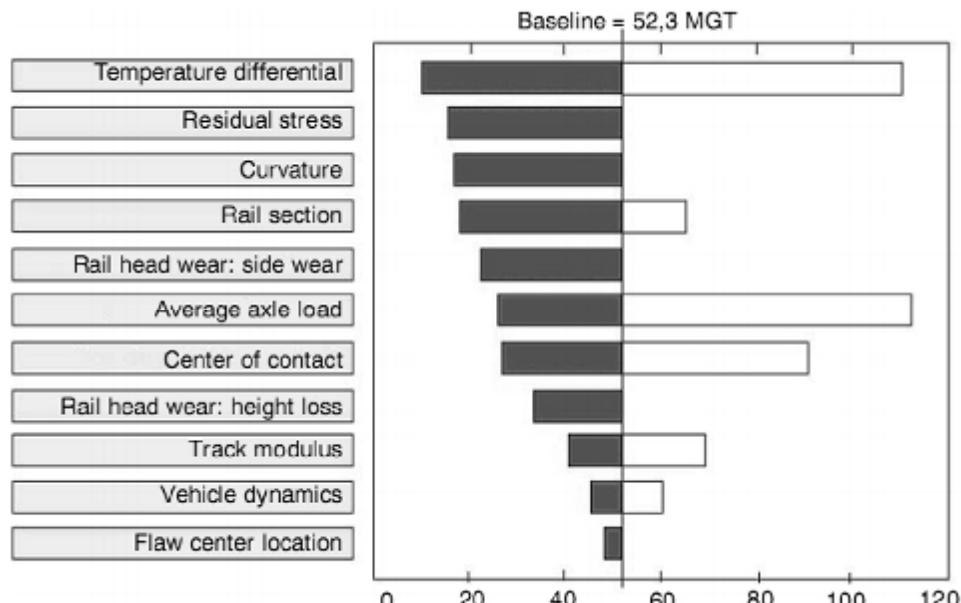
Slika 5. Uticaj različitih faktora na rast prsline (P-O interval) [10]
Figure 5. Influence of various factors on crack growth rate (variation of the P-F interval) [10]

As a part of the project [10], a sensitivity analysis was performed to demonstrate how different traffic and track conditions affect crack growth rate (see figure 5). Figure 5 shows the result of the analysis. The various factors are ranked according to the impact the crack growth caused has on rail life span.

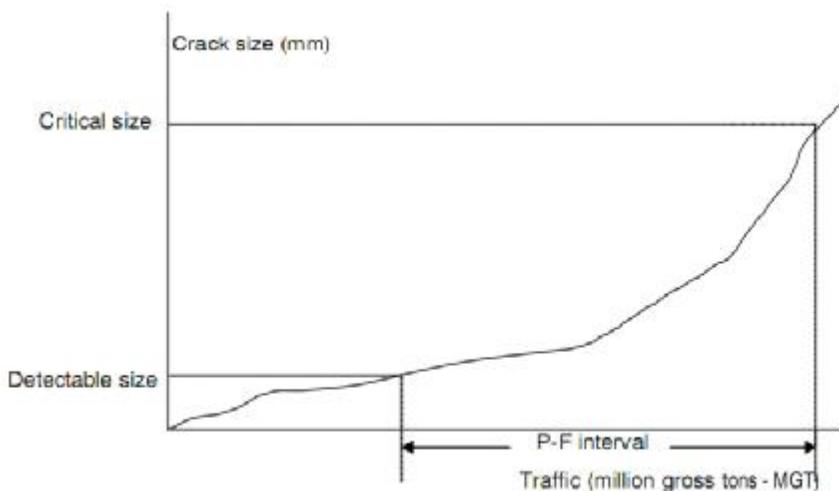
Slika 6. Definisanje $P-O$ intervala [10]
Figure 6. Definition of the $P-F$ interval [10]

Prslina se može pouzdano detektovati tek od njene određene veličine (P - potencijal razvoja prsline pre detekcije). Ova veličina zavisi od metode detekcije i predstavlja početnu veličinu od koje se prslina razvija sve do dostizanja kritične veličine, pri kojoj se može očekivati lom (O - otkaz usled loma). Za definisanje intervala $P-O$ može se koristiti proteklo vreme ili prevezeno saobraćajno opterećenje (izraženo u milionima bruto tona) u vremenskom intervalu između detekcije prsline i loma šine (slika 6).

A crack will have a certain detectable size (P -potential of crack development before detection). This depends on the detection technique used. From this size the propagation of the crack can be followed until it reaches the critical size where a rail break can be expected (F – failure due to breakage). The time or traffic load (expressed in million gross tons) between crack detection and rail break can be used to define the $P-F$ interval (figure 6).

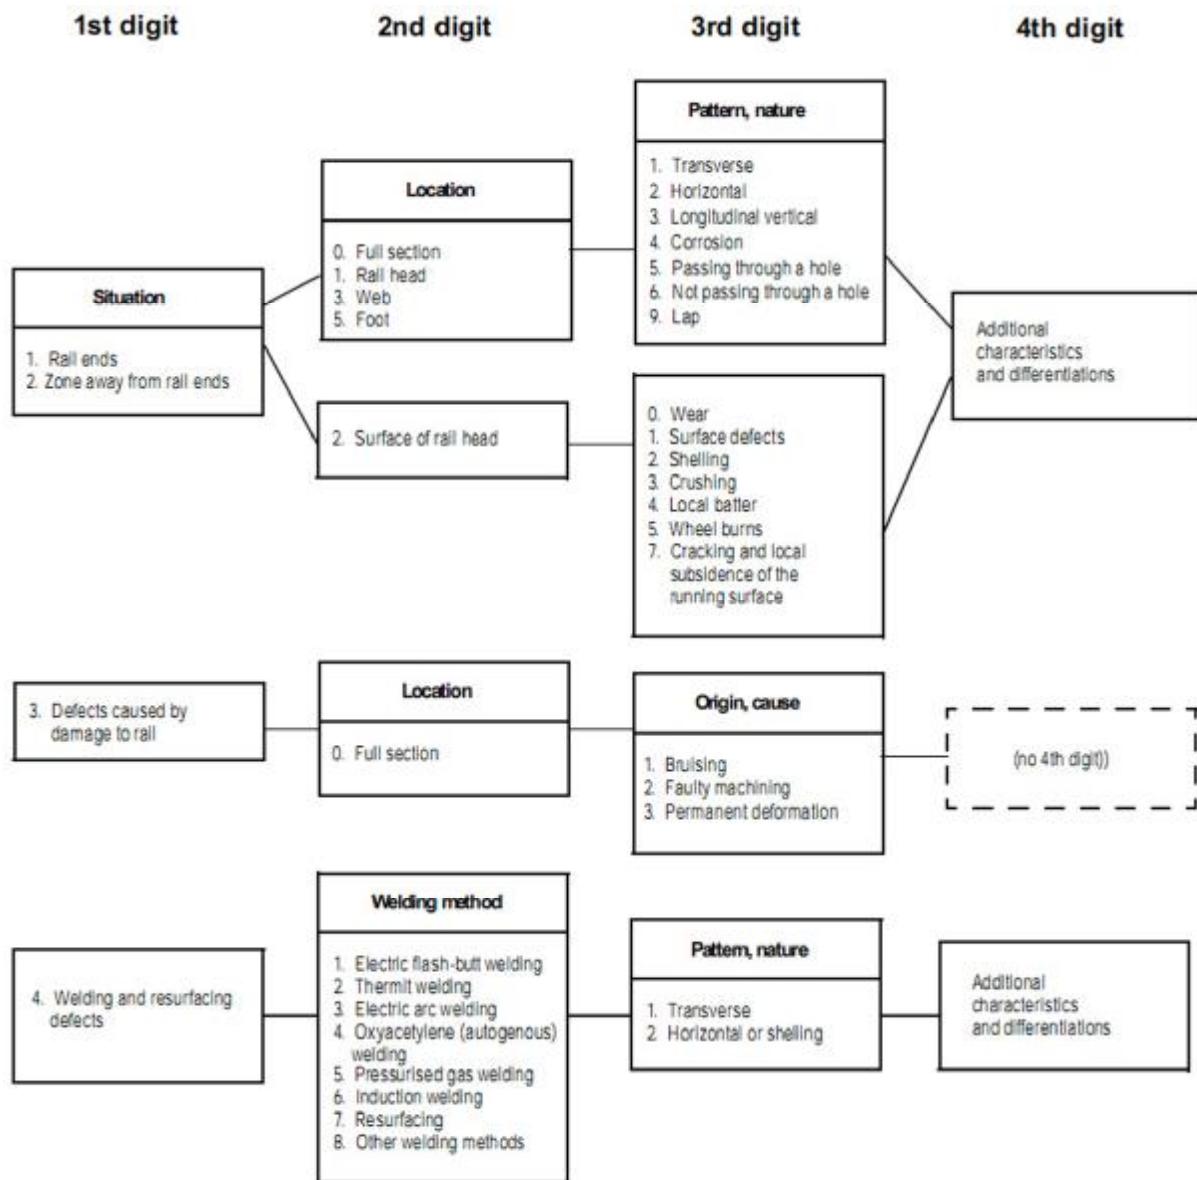
Slika 7. Princip kodiranja šinskih defekata [3]
Figure 7. Rail defect coding system [3]

Priručnik za šinske defekte (Handbook of rail defects - Code 712 Rail Defects) prema izdanju UIC iz 2002. godine obuhvata defekte tipa head checking i squat [3]. Princip kodiranja defekata prikazan je na slici 7. U tabeli 1 predstavljen je način kodiranja defekata head checking i squat.

The Handbook of rail defects (UIC CODE 712 - Rail Defects) includes head checking and squat type of defects, according to the UIC issue from 2002 [3]. Rail defect coding system is shown on figure 7. Table 1 shows the principle of coding defects head checking and squat.

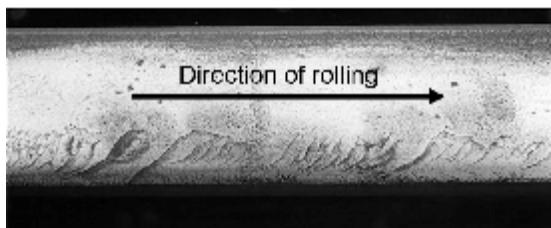
Slika 8. Izraziti primer oštećenja tipa head checking
Figure 8. Characteristic example of head checking rail defect

Ovaj defekt se javlja na spoljašnjoj šini u krivinama radiusa do 3000 m. Ipak, defekt se najčešće javlja pri radiusima krivina do 1500 m. Defekt se javlja na prelazu iz kotrlajuće površi na glavi šine (površina po kojoj se kotrlja točak šinskog vozila) u unutrašnju bočnu stranu glave. Defekt se uočava isključivo u kolosecima sa definisanim smerom vožnje (npr. dvokolosečna pruga) i sa velikim kvazi-statičkim opterećenjem po točku vozila (slika 8). Orientacija prsline zavisi od smera vožnje.

This defect occurs on the outer rail in the curves of radius up to 3000 m. However, the defect most frequently occurs in the curves of the radius of up to 1500 m. The defect occurs on gauge corner. Defect is distinguished exclusively on tracks with defined motion direction (for example, double track line) and with great quasi-static wheel load (figure 8). Fissure orientation depends on the direction of rolling.

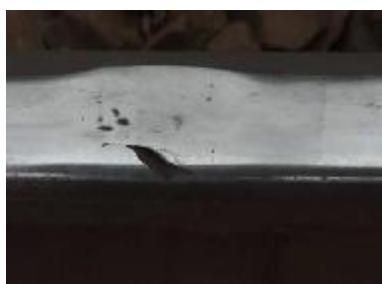
Slika 10. Head checking defekt sa odvajanjem čelika na zaobljenoj ivici glave šine
Figure 10. Head checking with the scaling (spalling)

Ukoliko se defekt ne otkloni na vreme, on napreduje dovodeći do odvajanja manjih ili većih delova šinskog čelika (slika 10). Razvijanjem prsline na dole, u krajnjem ishodu često dolazi do loma šine (slika 11).

If the defect is not removed in time, it advances leading to detachment of pieces of rail (figure 10). Fissure advancing downwards often results in the breaking of rail (figure 11).

Unless adequate grinding strategy is applied (in the right moment and to the minimum depth necessary), the possibility of fissure advancement to the point of flaking (figure 10) and rail breakage (figure 11) increases many-

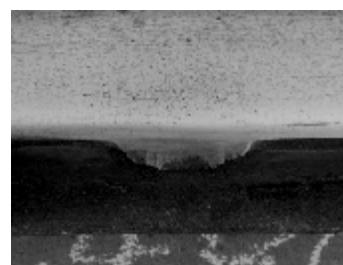
Slika 9. Bočno tečenje usled zamora materijala u glavi šine na jednokolosečnoj pruzi
Figure 9. Lateral flow of steel caused by rolling contact fatigue on the single track line

Defekt šina usled zamora materijala u šinama ugrađenim u koloseke jednokolosečne pruge manifestuje se na sasvim drugačiji način [2]. Usled promenljivog smera vožnje zamor materijala se manifestuje kao bočno tečenje čelika glave šine (slika 9).

Rail defect due to rolling contact fatigue on rails of the single track line manifests in an entirely different way [2]. Due to alterable direction of rolling, rolling contact fatigue manifests as lateral flow of the rail head steel (figure 9).

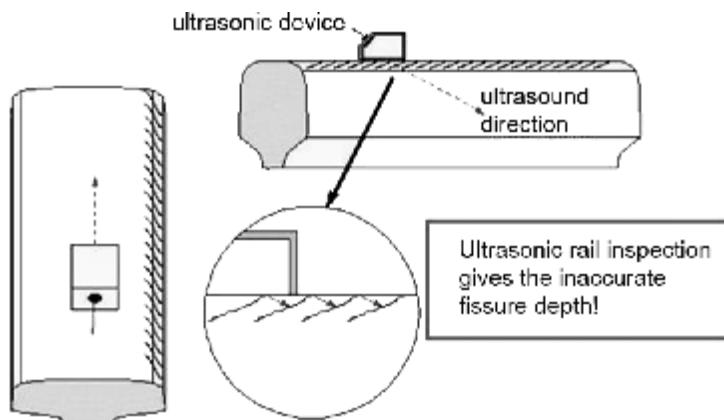
Slika 12. Nemogućnost primene ultrazvučnog ispitivanja za utvrđivanje dubine prsline head checking defekta [6]
Figure 12. Unreliable head checking fissures depth measurement with the usual ultrasonic inspection procedure [6]

Nepoznavanje brzine razvoja prsline i nepouzdanost merenja dubine prsline uobičajenim postupkom ultrazvučnog ispitivanja (slika 12) [6] su problemi koji se u praktičnim uslovima rešavaju periodičnim ciklusima brušenja šine u skladu sa iskustvima svake železničke uprave. Za sada se pažnja usmerava na kritična područja (npr. spoljašnja šina u krivini i sl.), koja su iskustveno prepoznatljiva po mogućim koncentracijama naprezanja i u njima na kritična mesta (npr. prelaz kotrljujuće površine na glavi šine u unutrašnju bočnu stranu glave šine) gde se prema iskustvu mogu očekivati prsline usled zamora.

In practical conditions, periodical cycles of rail grinding according to experience of every railway management solves the problems of not knowing the speed of the fissure development and unreliable fissure depth measurement with the usual ultrasonic inspection procedure (figure 12) [6]. For now, the attention is focused on critical areas (for example outer rail in the curve and similar), which are empirically recognizable by eventual stress concentration, and critical places inside critical areas (for example, gauge corner) where according to experience fissures due to fatigue could be expected.

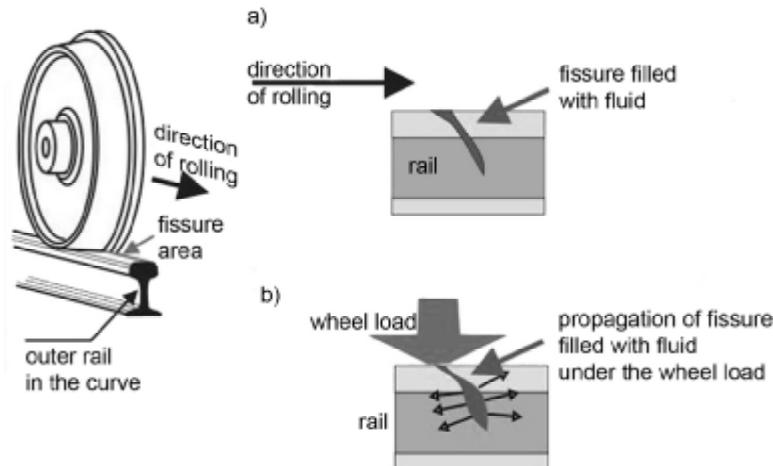
Slika 13. Širenje prsline usled prodiranja sredstva za podmazivanje u prslinu
Figure 13. Fissure propagation due to lubricant penetration

Jedna od uobičajenih preventivnih mera održavanja, koja se sprovodi na železničkim prugama je podmazivanje kako bi se smanjilo bočno habanje glave spoljašnje šine i habanje venca točka. Nažalost, ova mera pospešuje razvoj head checking defekta šine [1]. Usled prodiranja sredstva za podmazivanje u prsline (zajedno sa nečistoćama i atmosferskom vodom) i pritiska na zidove prsline pod točkom dolazi do bržeg napredovanja i širenja prsline (slika 13).

One of the usual preventive maintenance measures used on railways is lubrication in order to decrease lateral rail wear of the outer rail and wheel flange wear. Unfortunately, this measure stimulates head checking rail defect [1]. Lubricant penetrating inside fissures (together with impurities and atmospheric water) and the pressure from the wheel on fissure walls lead to faster advancement and dilatation of fissure (figure 13).

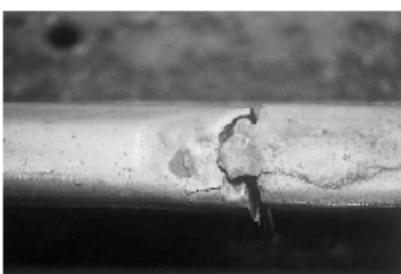
Slika 16. Lom šine usled oštećenja tipa squat
Figure 16. Example of breakage under a squat

With time, the crack is expanding towards inner side of the rail head. The cracks propagate inside the head, at first at a shallow angle to the surface. Then, when they reach 3 to 5 mm depth, they propagate downward transversely, producing the fracture of the rail (figure 16).

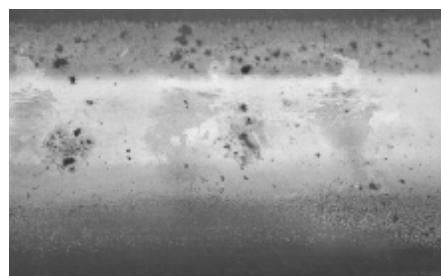
Slika 17. Defekt tipa belgrospi
Figure 17. Belgrospi

Defekt se javlja na naboranoj šinskoj glavi u vidu prslina akumuliranih na vršnim delovima naborane površi glave šine. Defekt se može opisati i kao mešavina nepravilno raspoređenih head checking defekata i minijaturnih defekata tipa squat (slika 17).

The defect occurs on the rail-head corrugation in the form of cracks accumulated on the ridges of the corrugation surface. Defect could also be described as a composition of unevenly distributed head checking defects and miniature squat defects (figure 17).

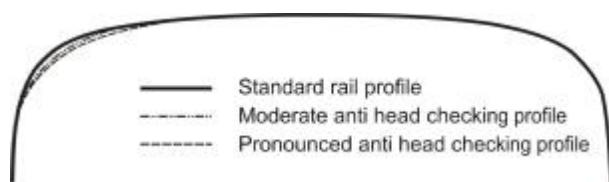
Slika 19. Opšti princip anti head checking profila

Figure 19. General principle of anti head checking profile

Some railway managements in Europe have recently developed special rail profiles where removing rail steel from the critical zone by grinding creates free space between the wheel flange and the running surface of the rail. Profile geometry differs according to the local specifics of every railway (figure 19) [9].
