Procedia Engineering 117 (2015) 596 – 608

International Scientific Conference Urban Civil Engineering and Municipal Facilities,
SPbUCEMF-2015

The Importance of Rail Inspections in the Urban Area -Aspect of Head Checking Rail Defects

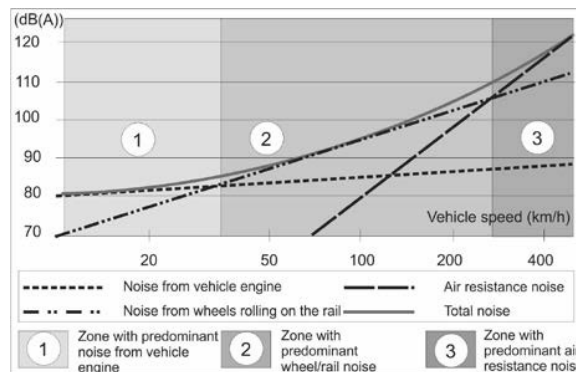
Fig. 2. Levels and sources of railway noise depending on the vehicle speed

By analyzing the structure of noise emission (Fig. 2), it can be concluded that noise in the wheel/rail contact is the major problem in the widest speed range. Therefore, the condition of rail head surface is very important. It is influenced by subgrade condition [5, 6], substructure condition [6-11], track geometry [12] and vehicle condition. This research only deals with the condition of rail head surface that is the result of the appearance of rail defects due to the rolling contact fatigue (RCF).

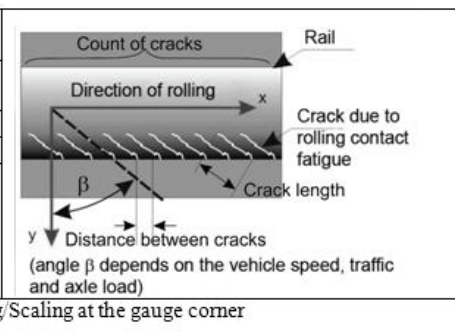
Fig. 8. The principle of coding for HC rail defect according to [19] and typical orientation of HC fissures on the rail head

Defect is distinguished on tracks with a defined traffic direction (for example, on double track line). In accordance with [19], the code number for HC defect is 2223 (Fig. 8).

Position of digit in the code:		The meaning of digit in the code:
1st digit	2	Defect zone away from rail ends
2nd digit	2	Surface of rail head
3rd digit	2	Shelling
4th digit	3	Fissuring and/or scaling at the gauge corner
Code:		2223 - Head checking/Fissuring/Scaling at the gauge corner

Visually observed HC defects are classified according to the crack length on the rail head surface (Fig. 8). The rail sections with 50 m length are classified with respect to the maximum crack length according to Table 1 [17,25].

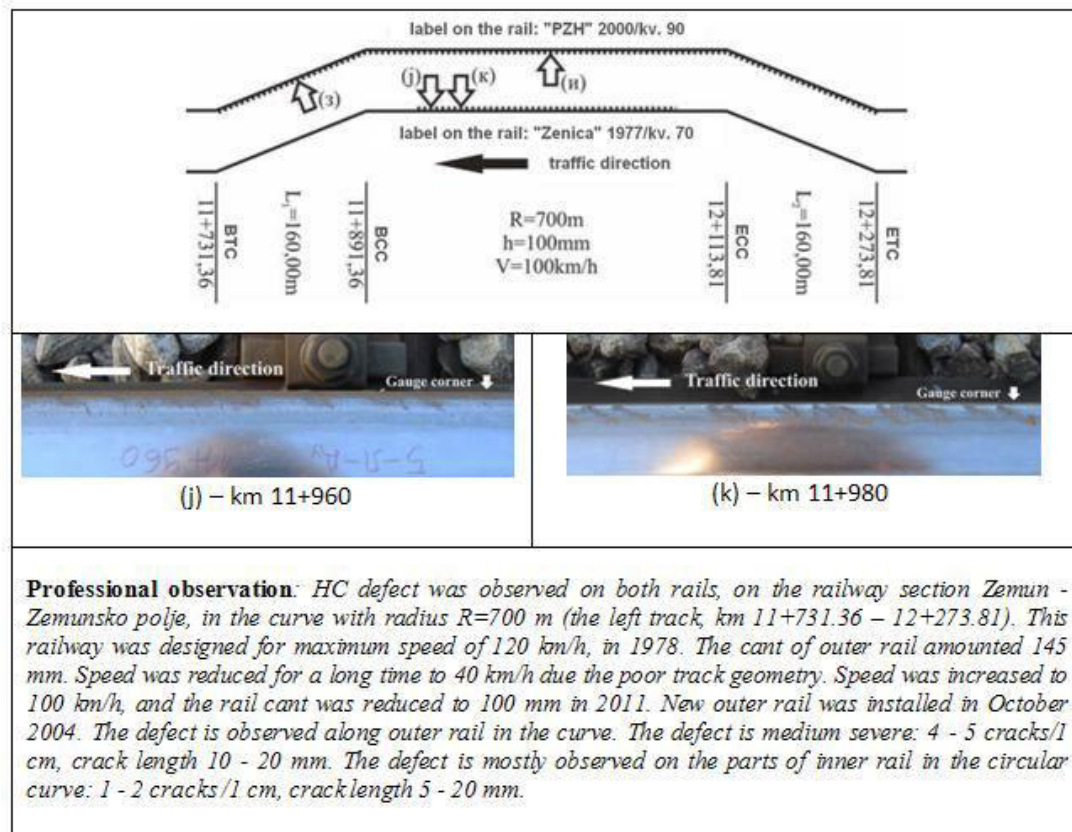
Fig. 9. An example form with the sketch, photographs and professional observation on the Serbian Railways

Visual Inspection. Rail network should be inspected visually twice a year (every six months), with the help of photographs and video images. This method takes a huge number of man-hours and includes the subjectivity. It is recommended for sections with 50 m length, which are classified with respect to the maximum crack length (Fig. 5). Pieces of information about RCF defects, which were observed during the visual inspection, are entered in the form in accordance with [19] and saved in a database. The other necessary details and photos of RCF defect are attached to the form (Fig. 9).

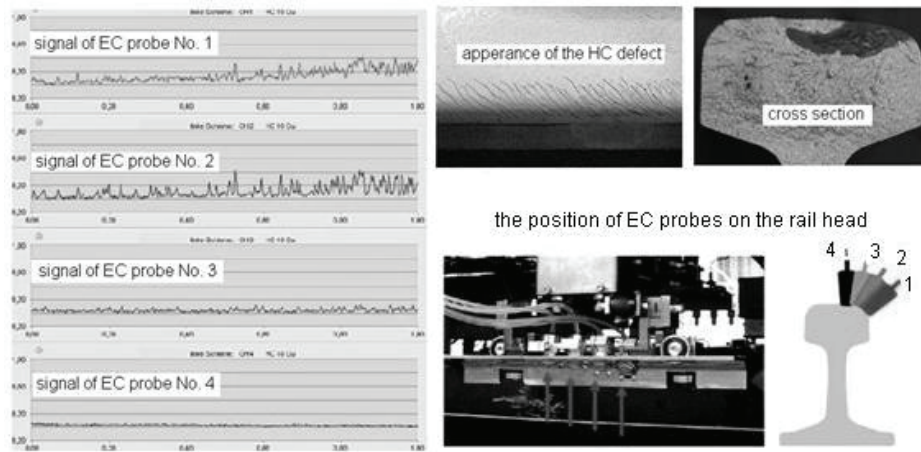
Fig. 14. The position of EC probes on the rail head and characteristic signals on the rail gauge corner with HC defects [31]

Fig. 14 shows the vehicle equipped with eight-channel device for rail testing using the eddy current: four sensors on the left and four sensors on the right rail [31].
